## Inspection Report

Permit Holder: FortisBC Energy Inc.  
Inspection: 2023-3137  
Inspection Date: 2023-10-24  
Inspection Outcome: In Compliance

#### Woodfibre Site

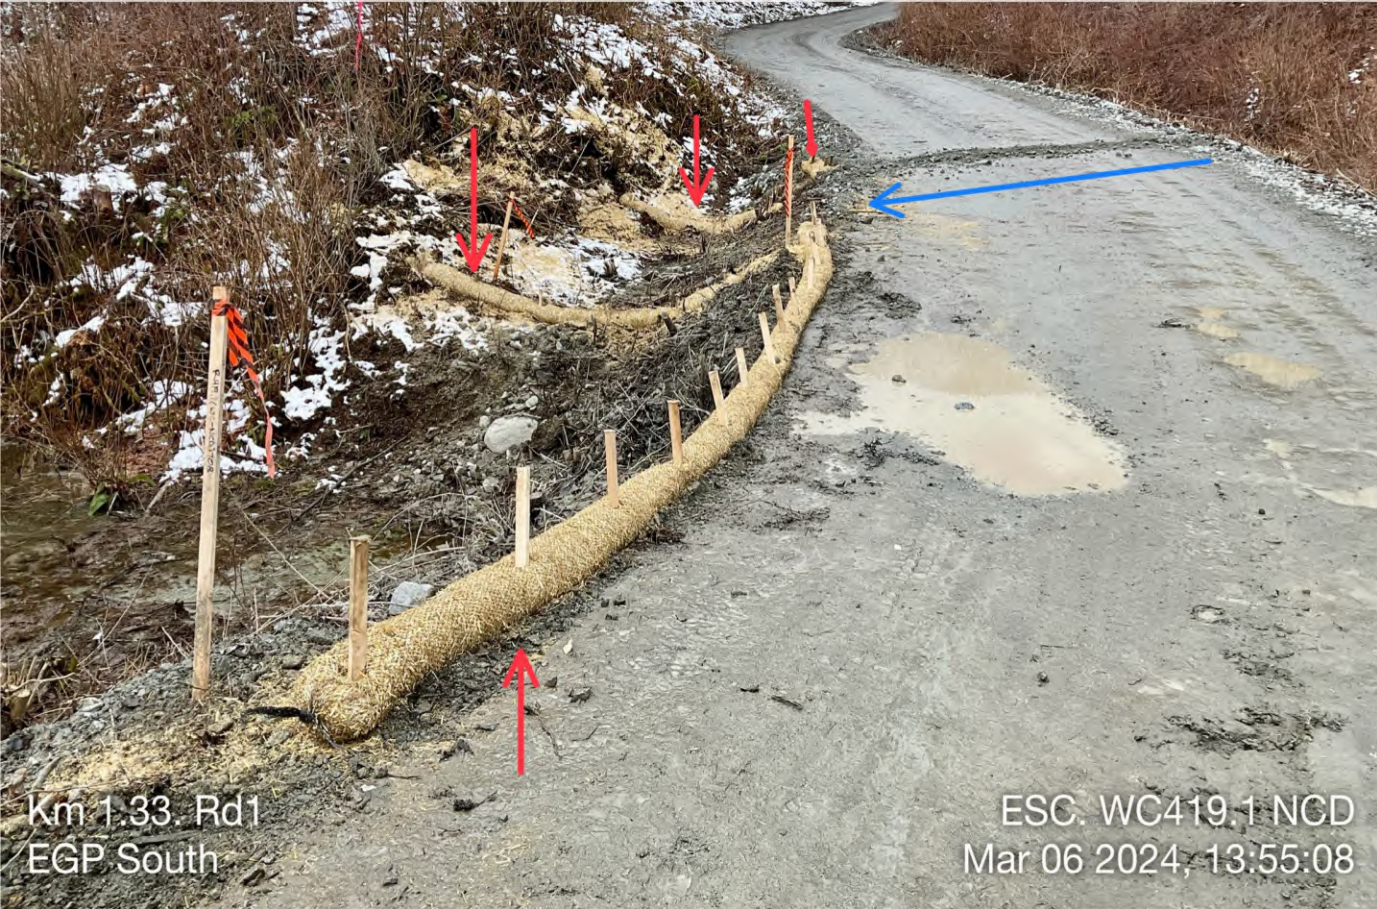
Km 1.33 Rd1  
EGP South

ESC. WC419.1 NCD  
Mar 06 2024, 13:55:08

Road upgrades are planned for this section of road that will include capping with aggregate and crowning the road to mitigate pooling of water at this location. Discussions have been had with crews on lowering speed when pooling water is observed on the roads. Drainage, Erosion and Sediment Control (DESC) inspections occur regularly to verify effectiveness of DESC measures and maintenance of these measures occur as required, based on site conditions and weather.

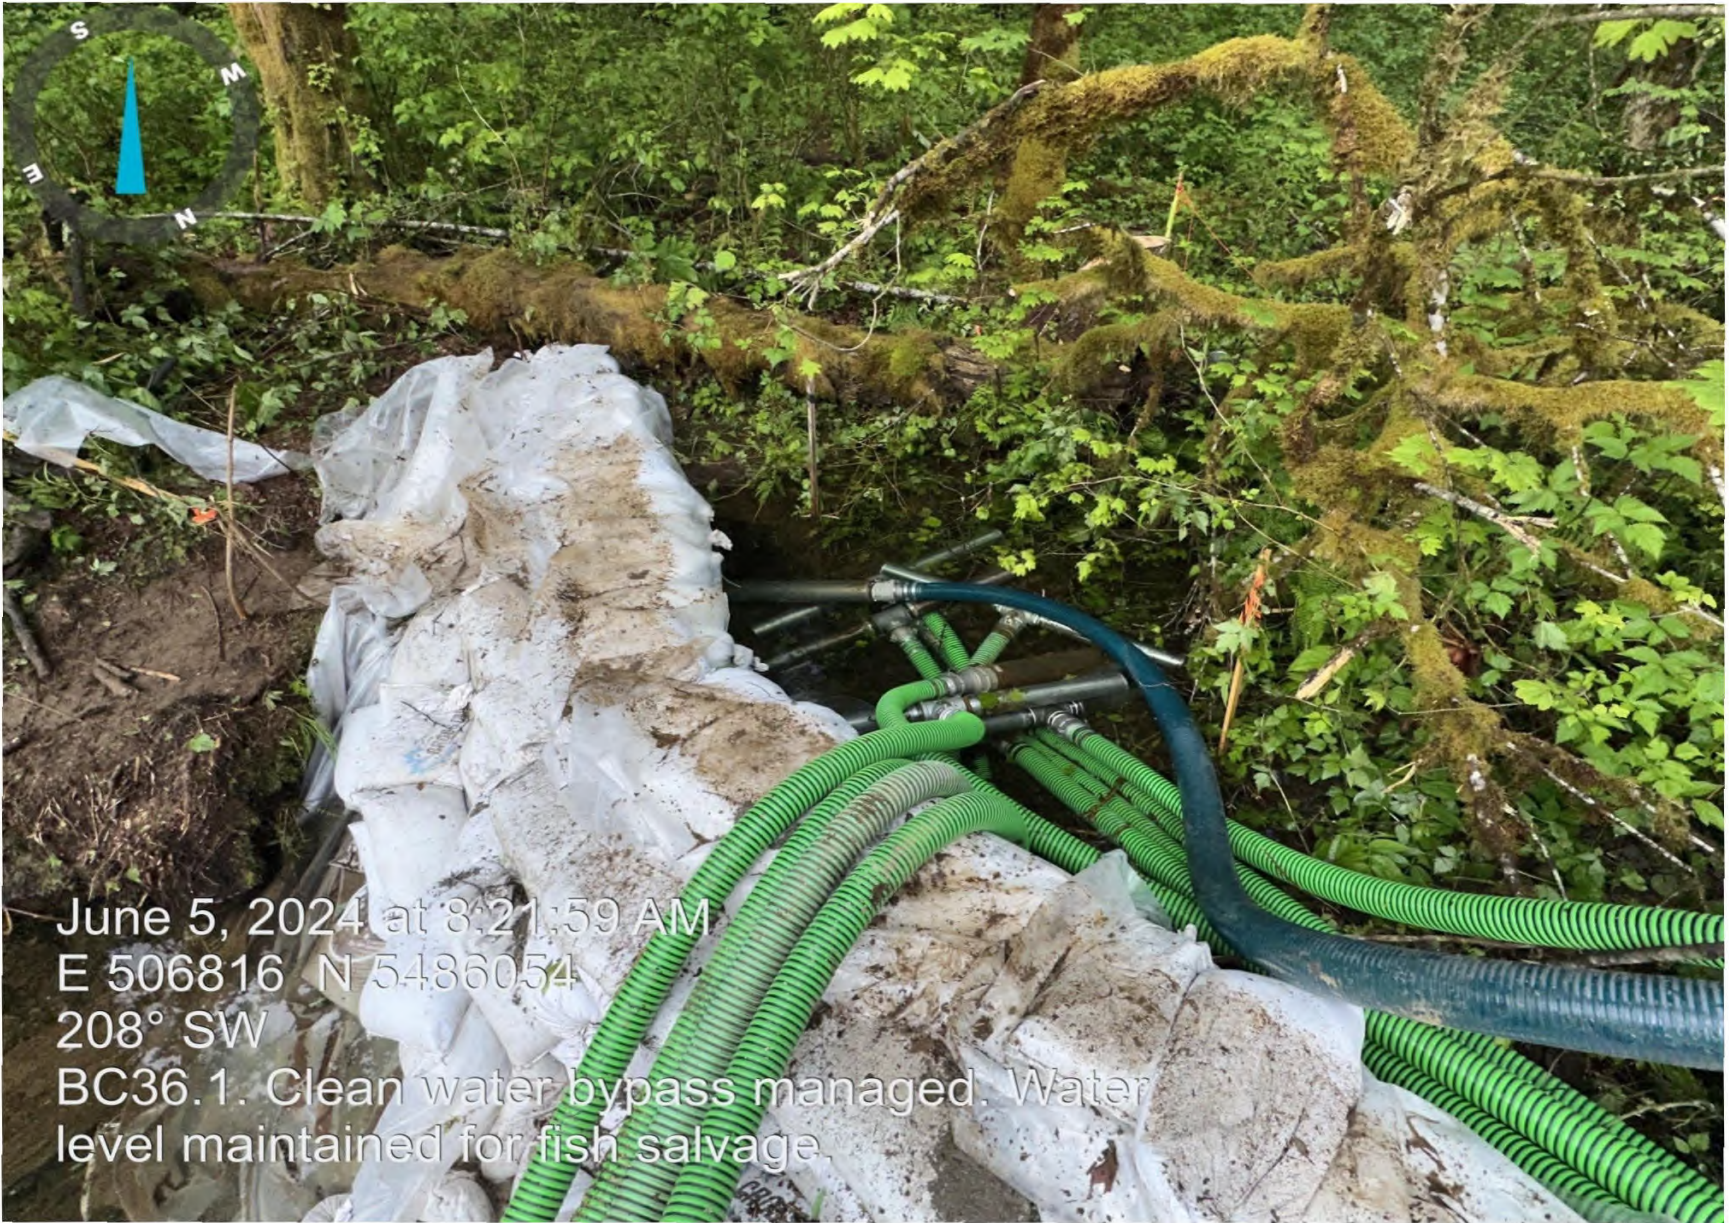
June 5, 8:21 am - viewing upstream isolation, clean water bypass. Pumps managing flow with no seepage past dam.

June 5, 2024 at 8:21:59 AM  
E 506816 N 5486054  
208° SW  
BC36.1. Clean water bypass managed. Water  
level maintained for fish salvage.

No flow observed at secondary dam installed yesterday to control seepage.

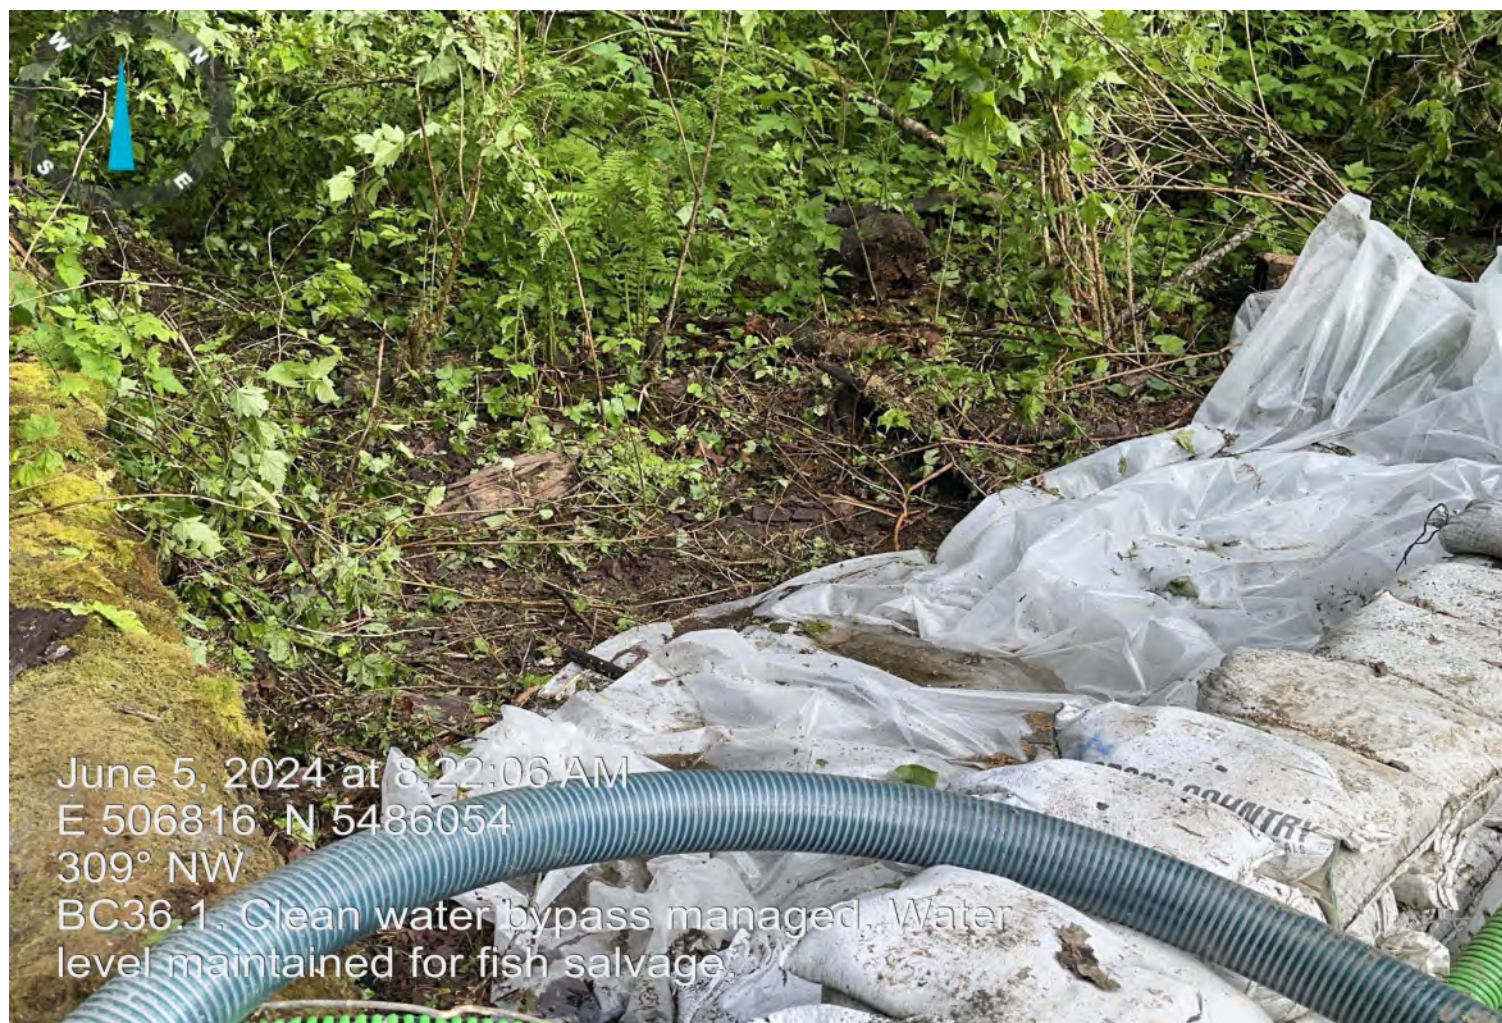
Viewing water level maintained to high water mark upstream of isolation in WC 36.1

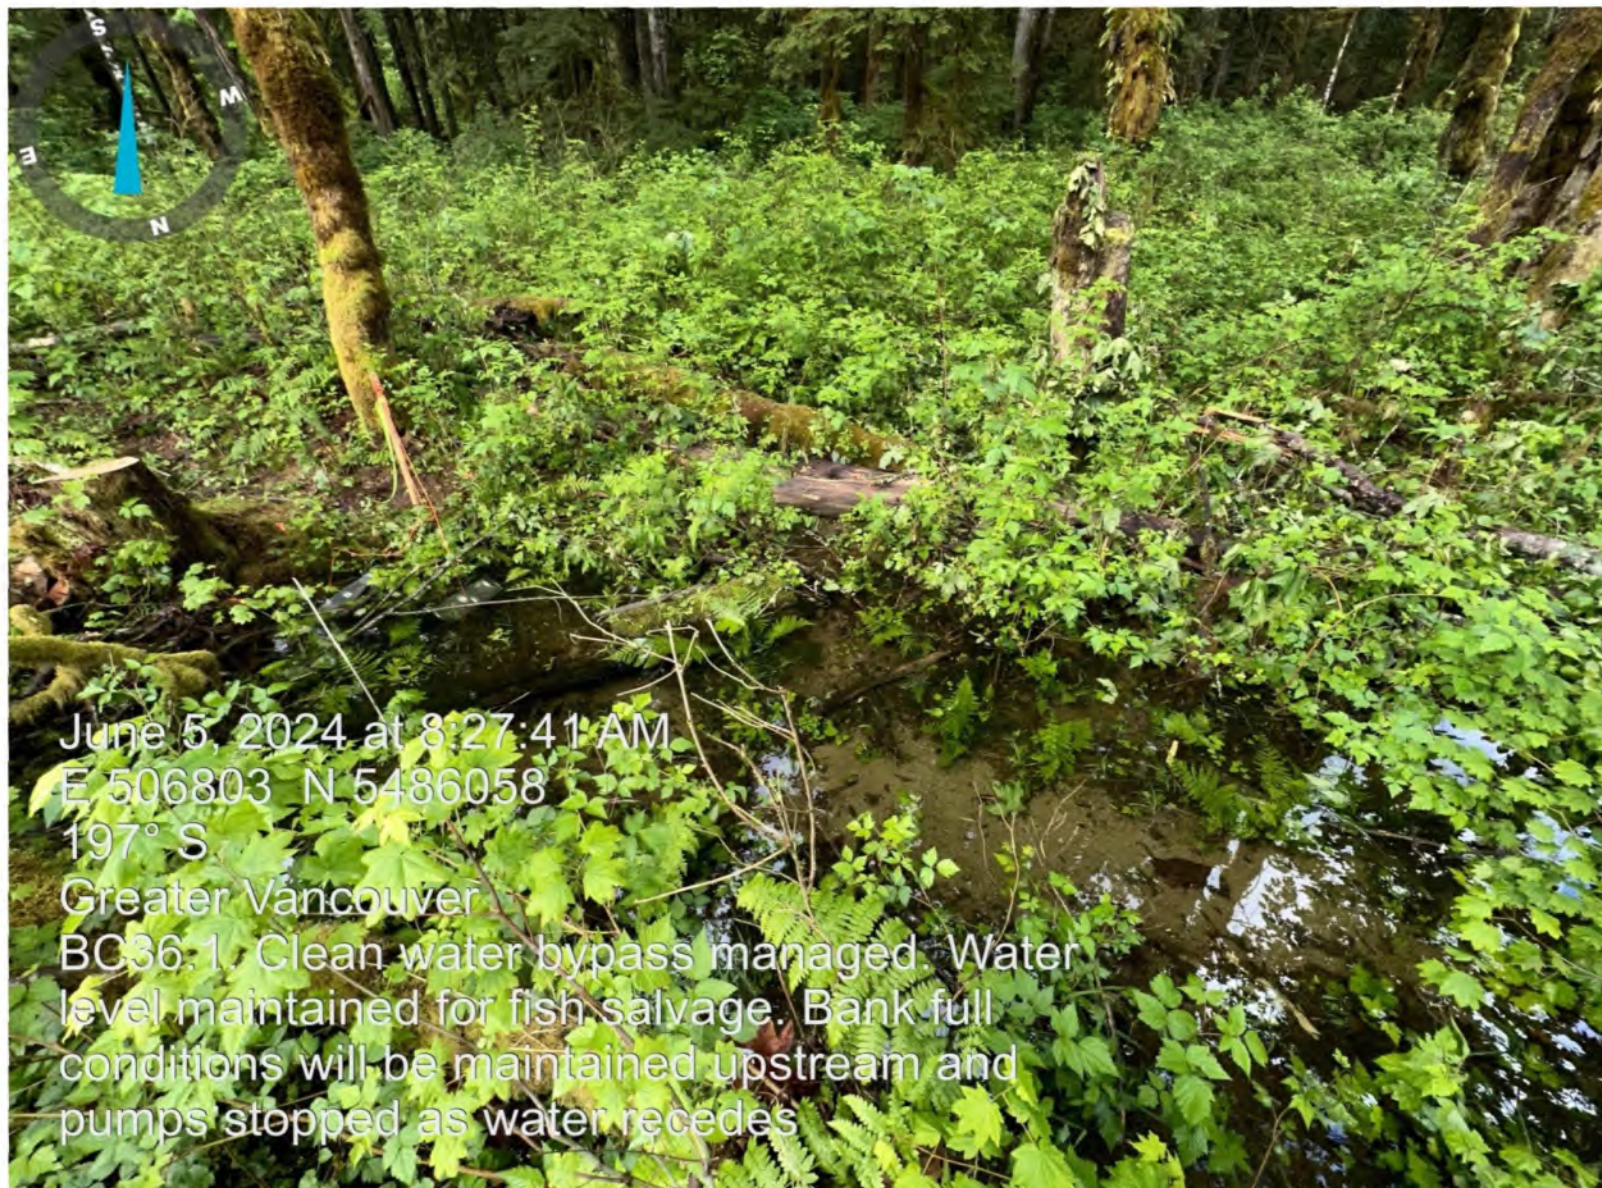
Water level dropping at the Indian River. No fish stranded.

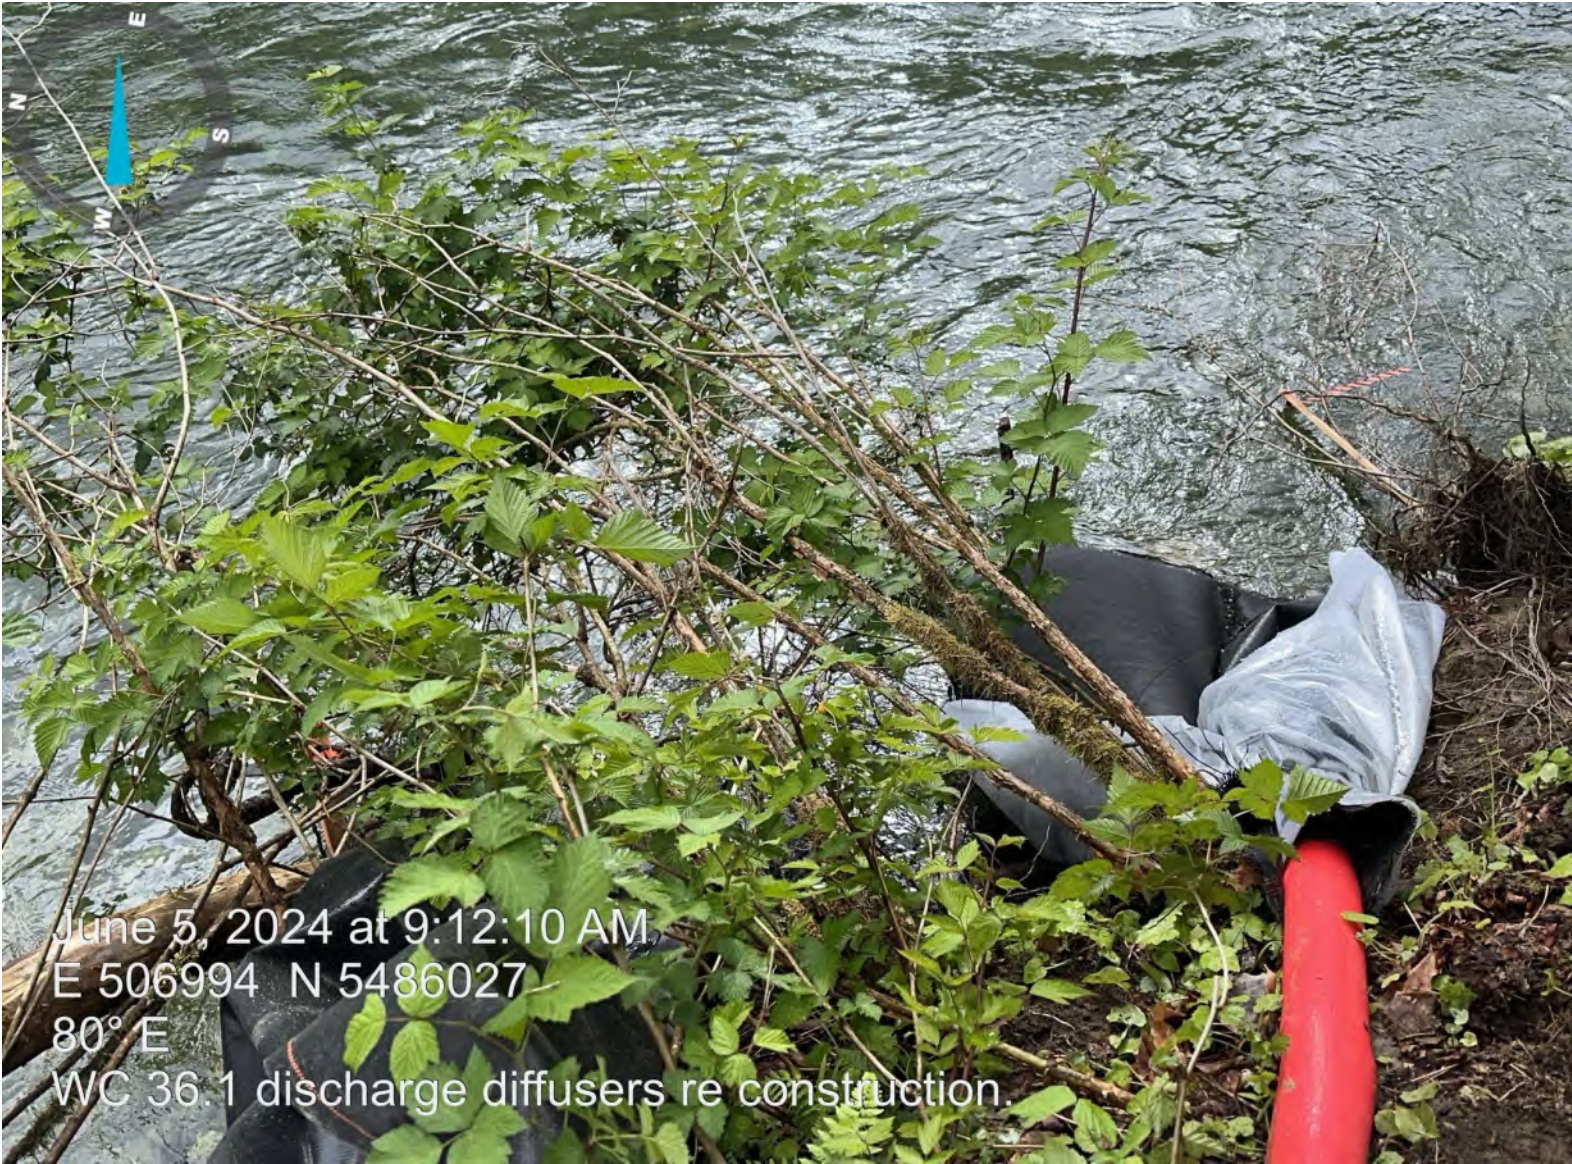
Discharge diffusers re constructed to prevent erosion along the right bank.

June 5, 2024 at 9:12:10 AM  
E 506994 N 5486027  
80° E  
WC 36.1 discharge diffusers re construction.

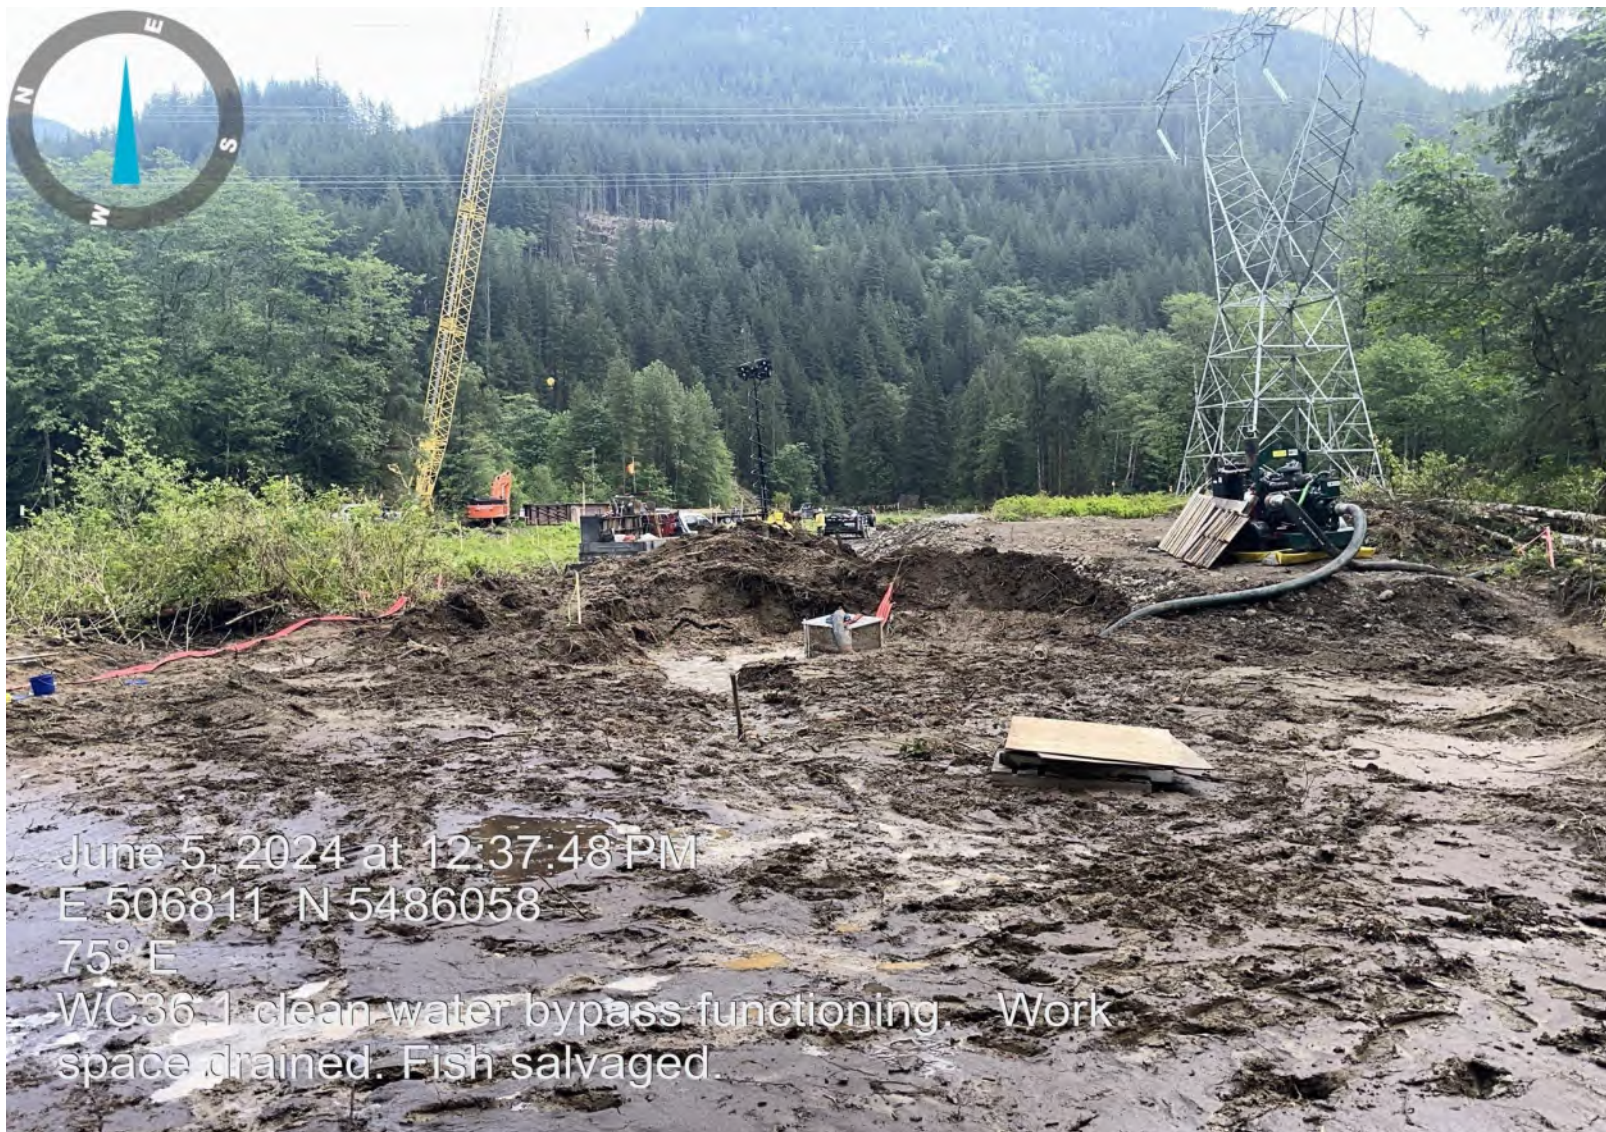
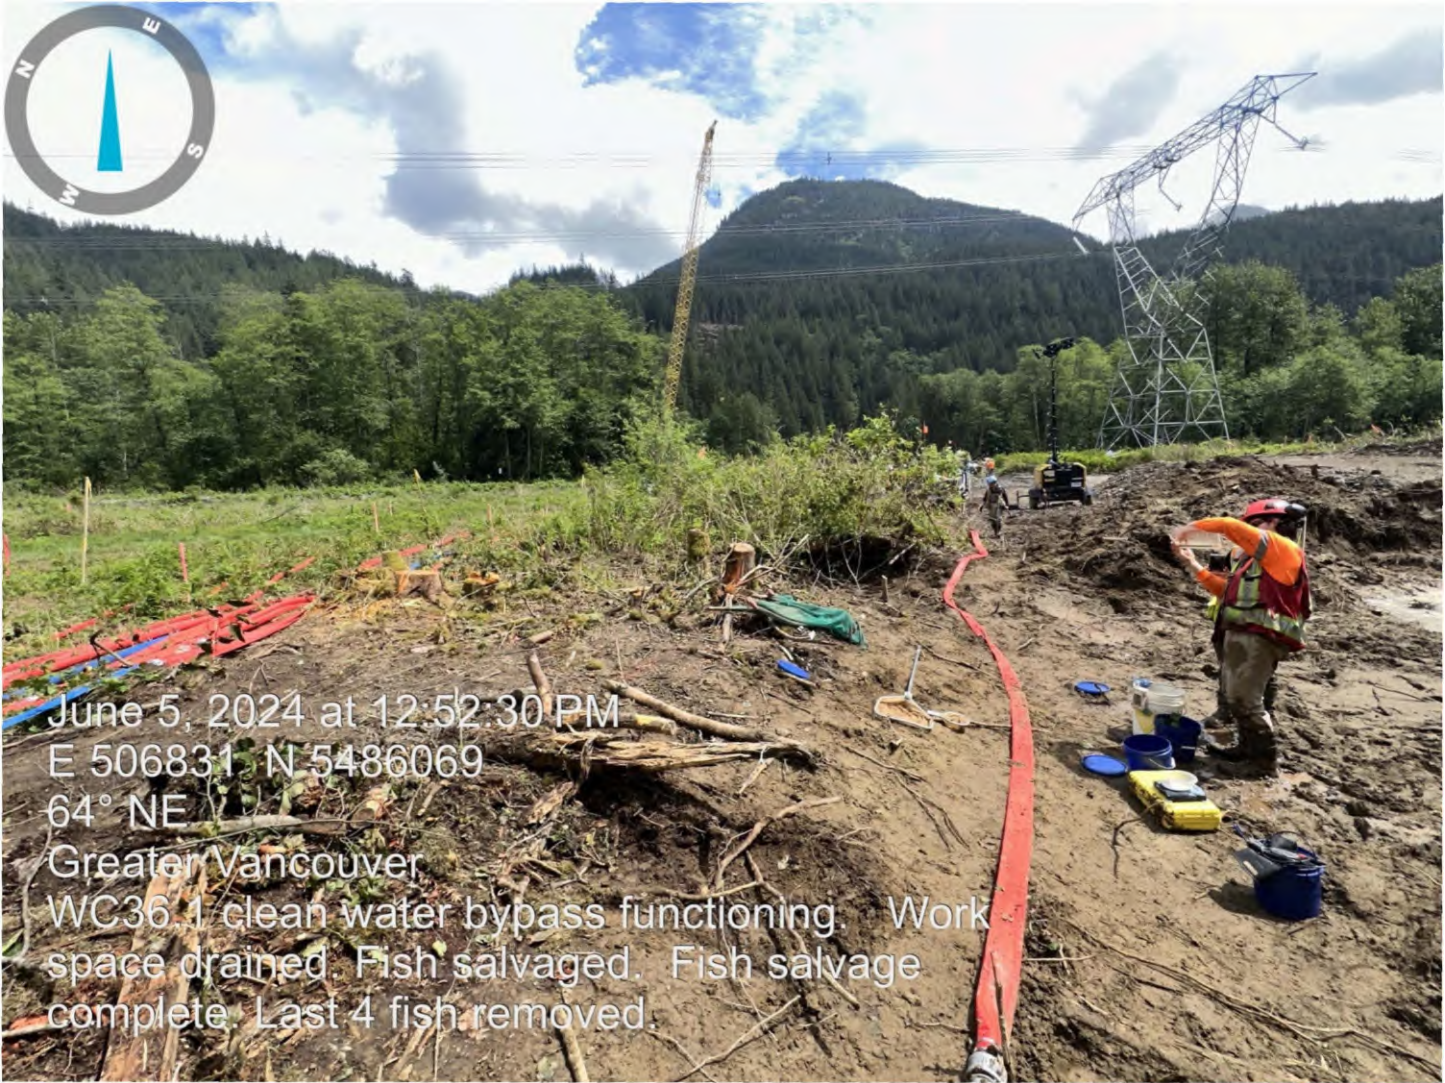
Fish salvage complete. All fish relocated from workspace downgradient from WC 36.1 isolation as water was drawn down with QP on site.

June 5, 2024 at 12:52:30 PM  
E 506831 N 5486069  
64° NE  
Greater Vancouver  
WC36.1 clean water bypass functioning. Work  
space drained. Fish salvaged. Fish salvage  
complete. Last 4 fish removed.

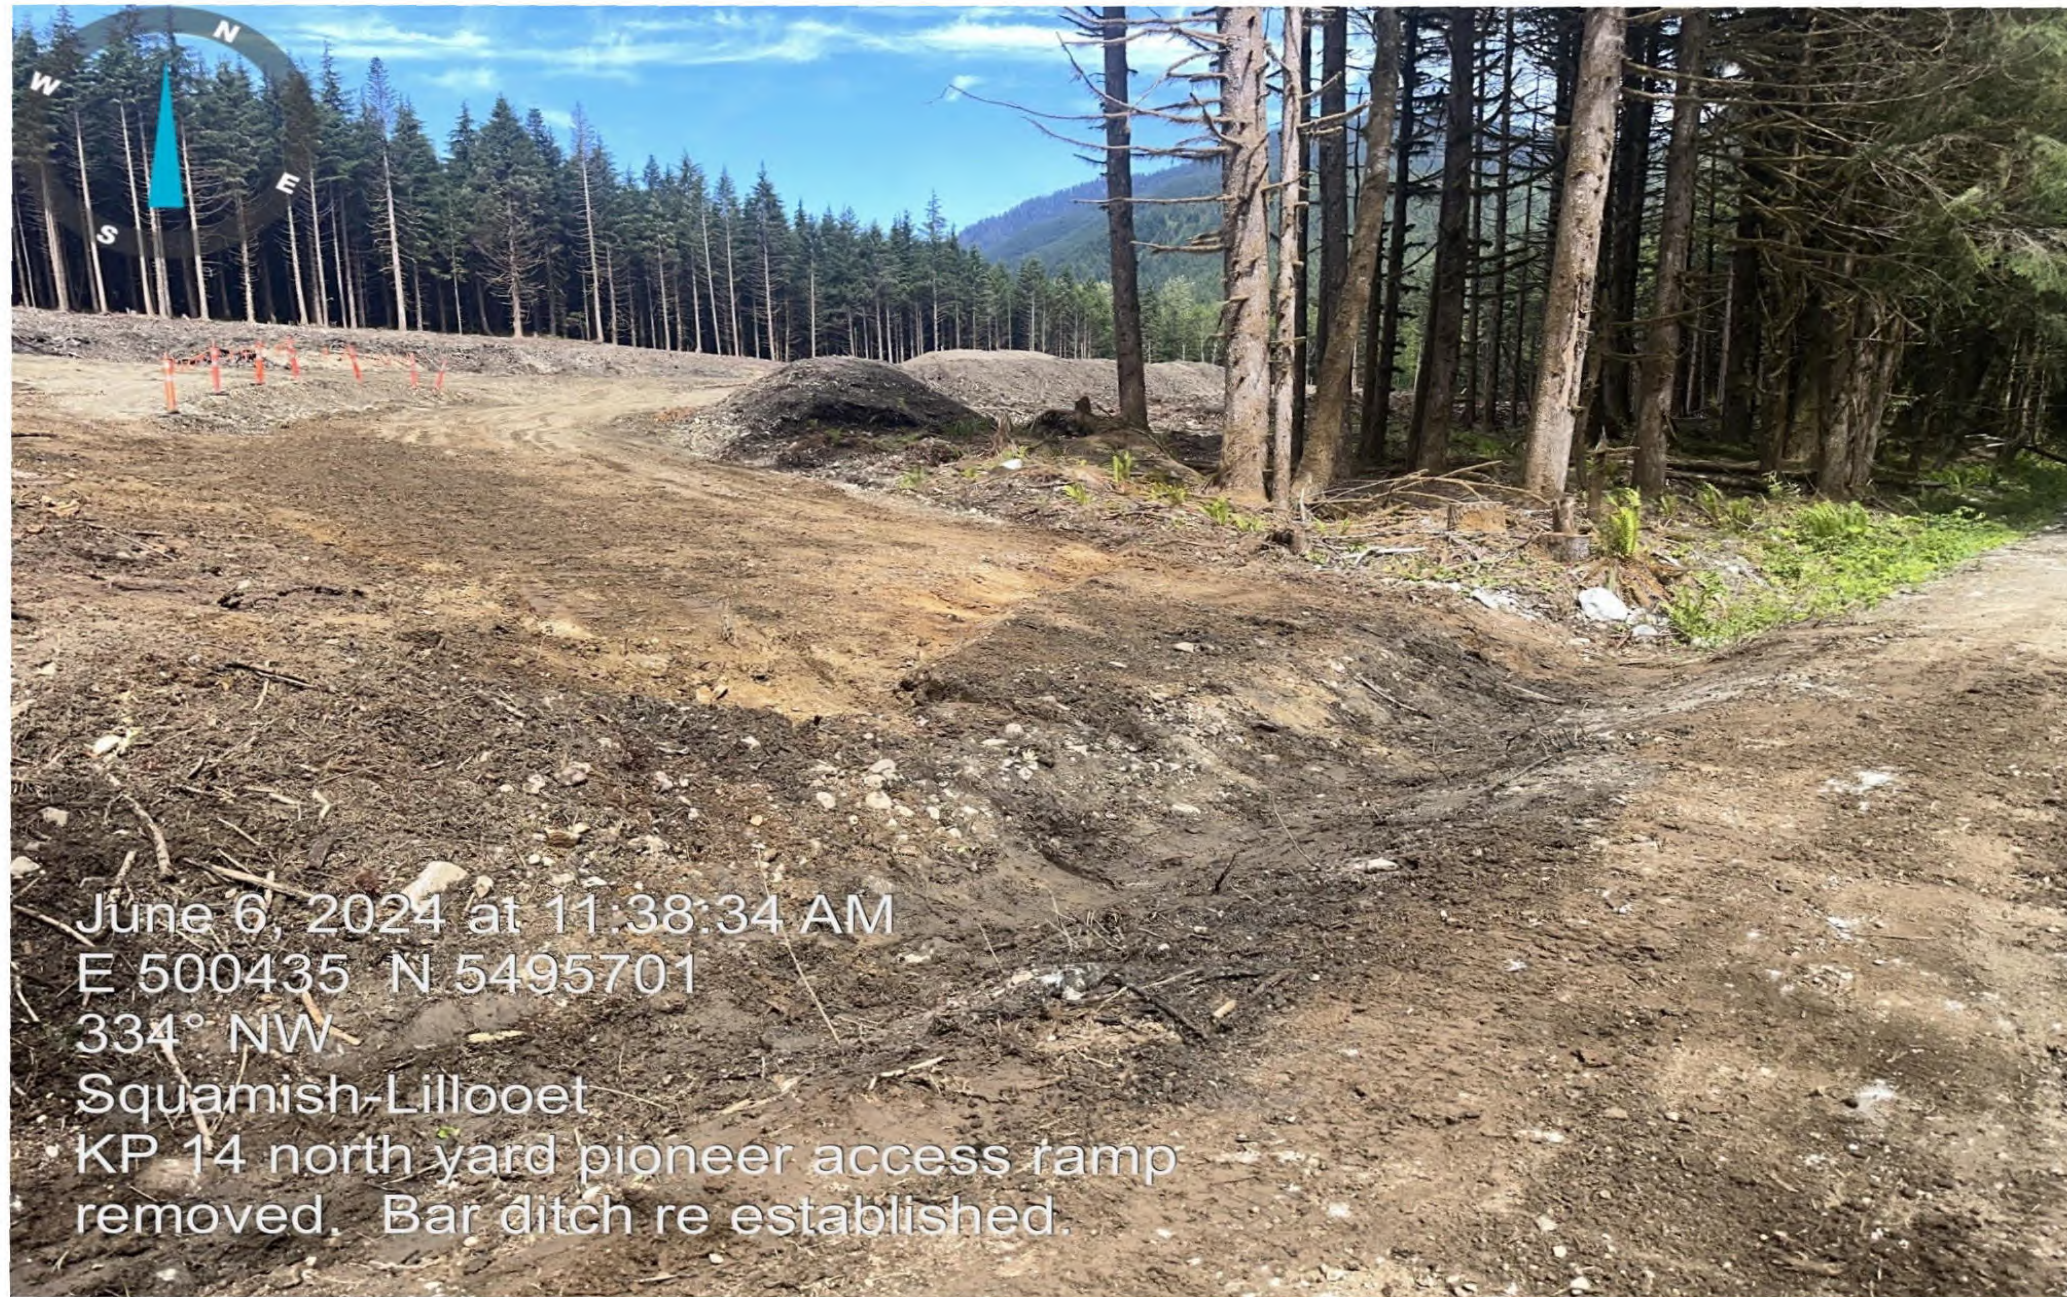
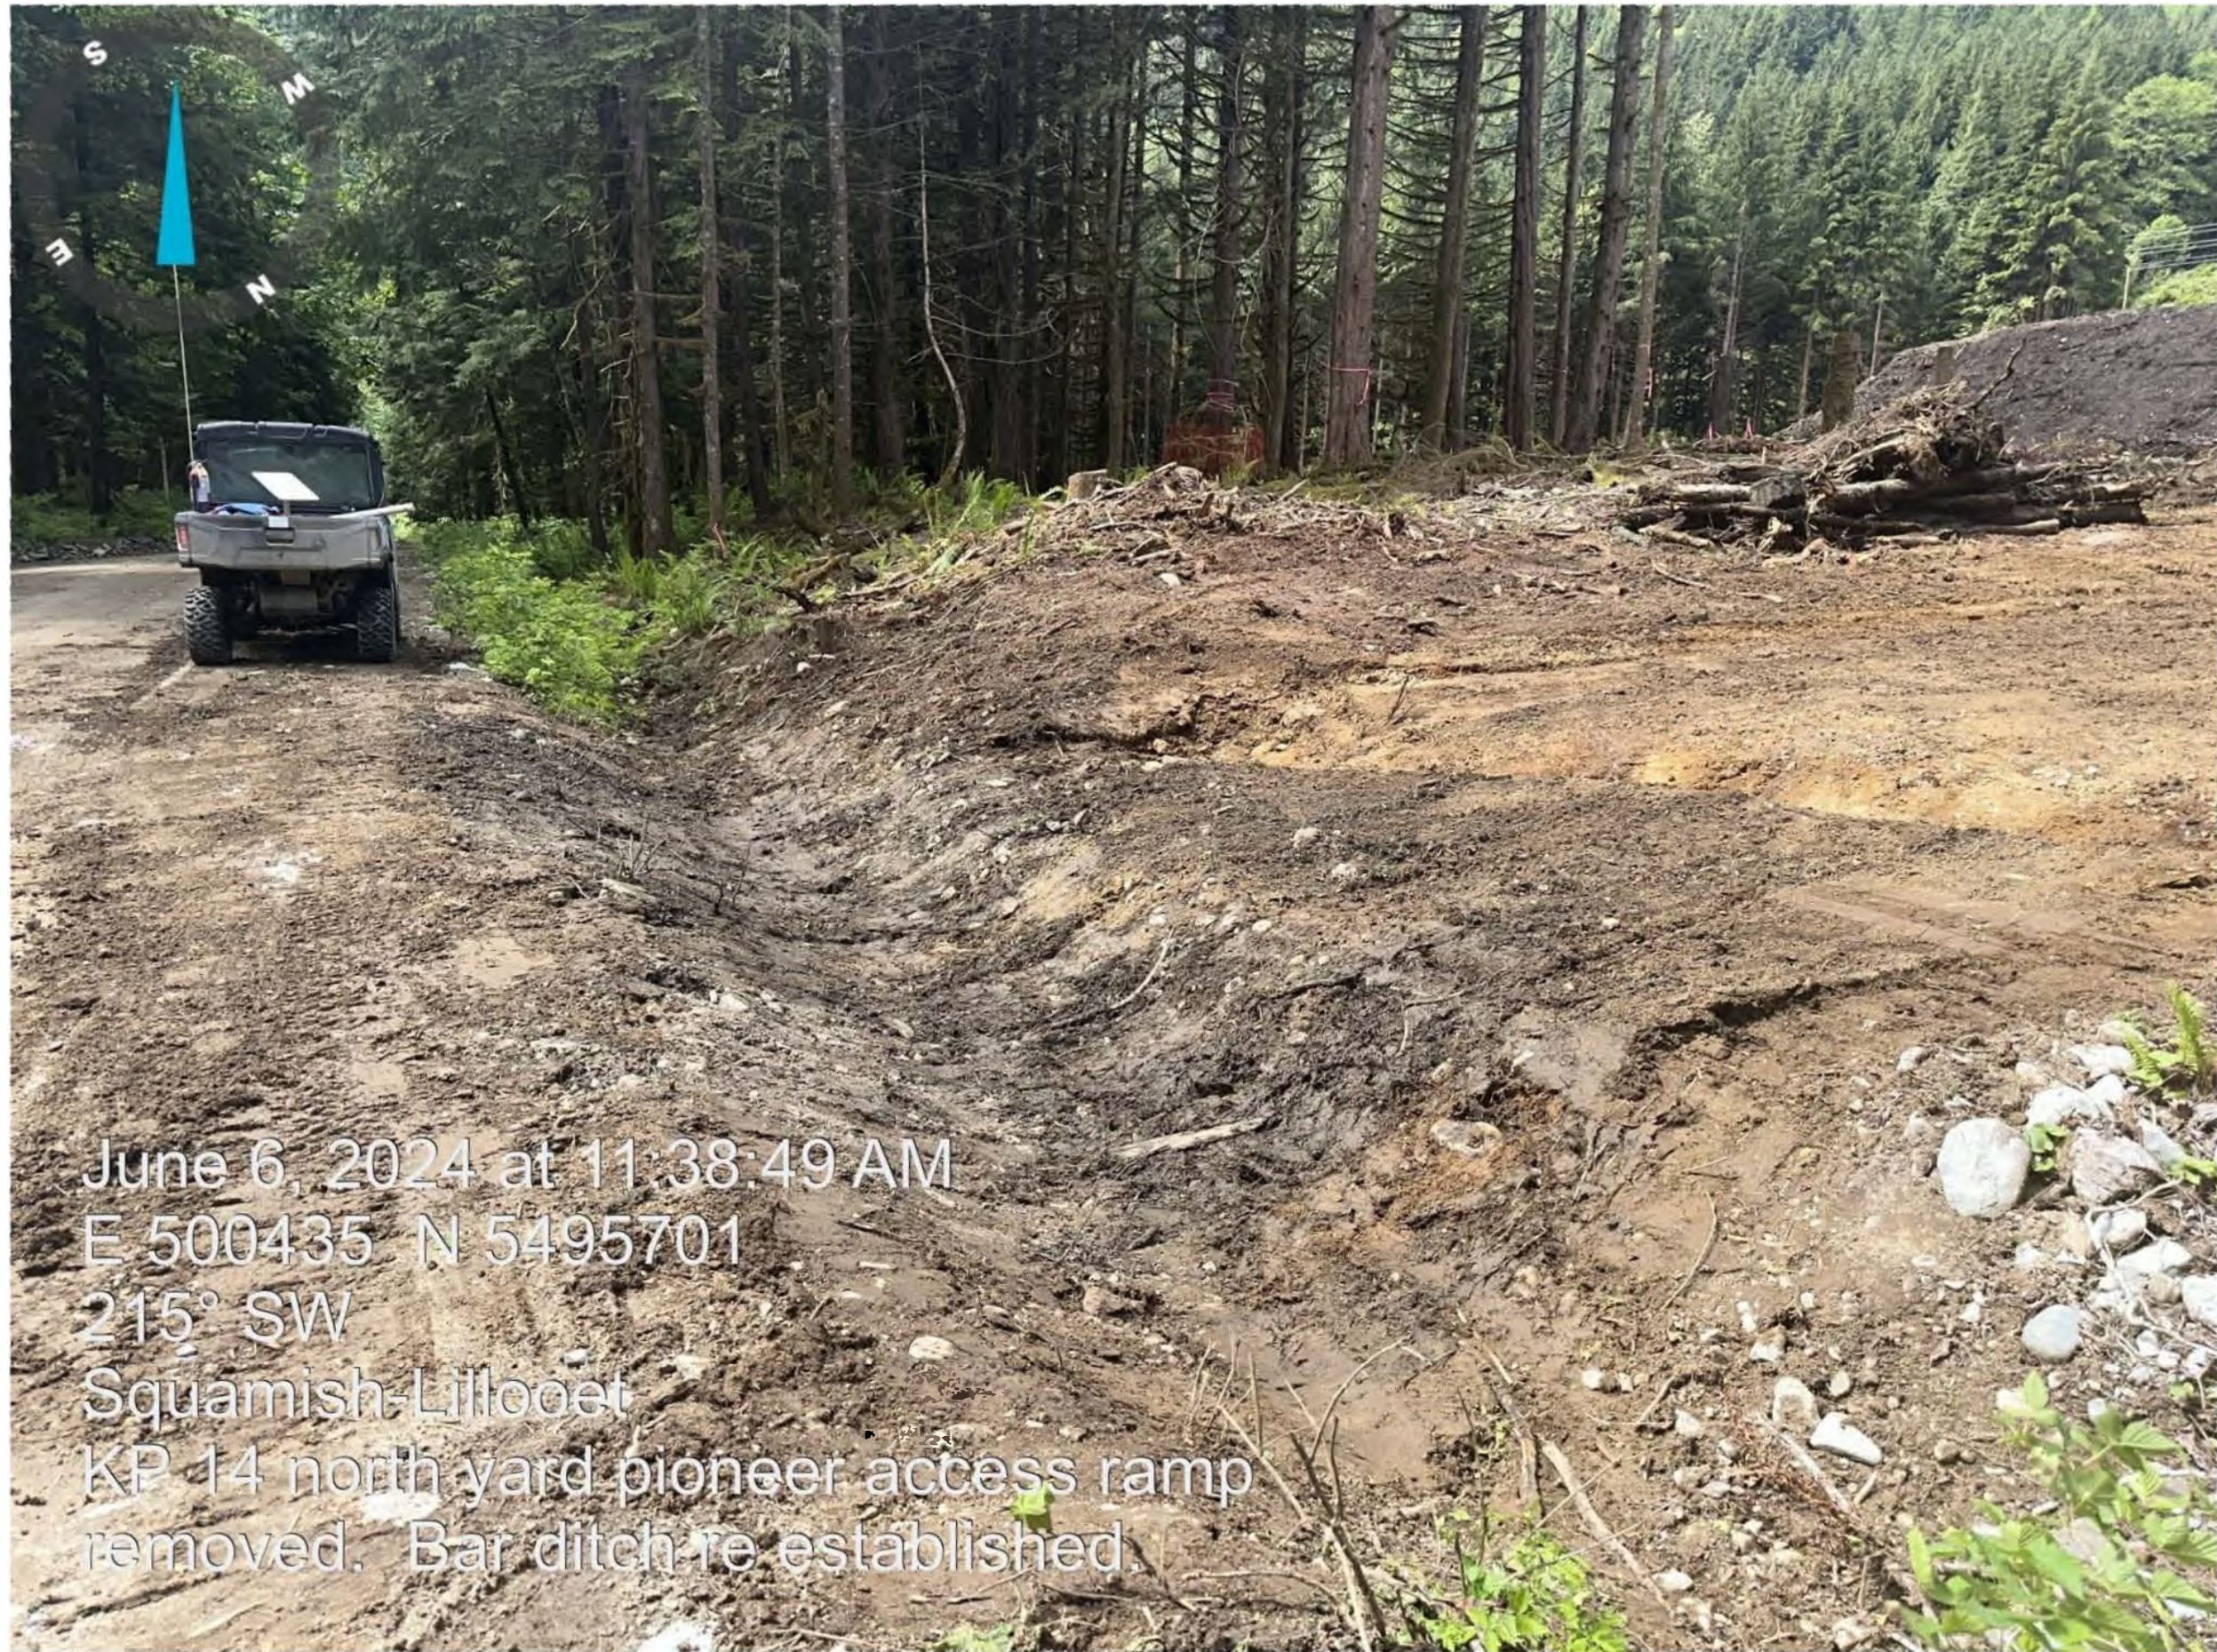
KP 14 upper laydown pioneer access removed and bar ditch re-established

June 6, 2024 at 11:38:49 AM  
E 500435 N 5495701  
215° SW  
Squamish-Lillooet  
KP 14 north yard pioneer access ramp  
removed. Bar ditch re established.

Following up to provide photo documentation of the two additional action items identified during the BCER inspection of EGP North on June 4, 2024. The pioneer access from the Stawamus-Indian FSR and upper KP 14 laydown has been removed and the ditch line re-established. When the laydown area access is required in the future, a ramp and culvert will be installed.
