## Inspection Report

Permit Holder: FortisBC Energy Inc.  
Inspection: 2023-3137  
Inspection Date: 2023-10-24  
Inspection Outcome: In Compliance

#### Woodfibre Site

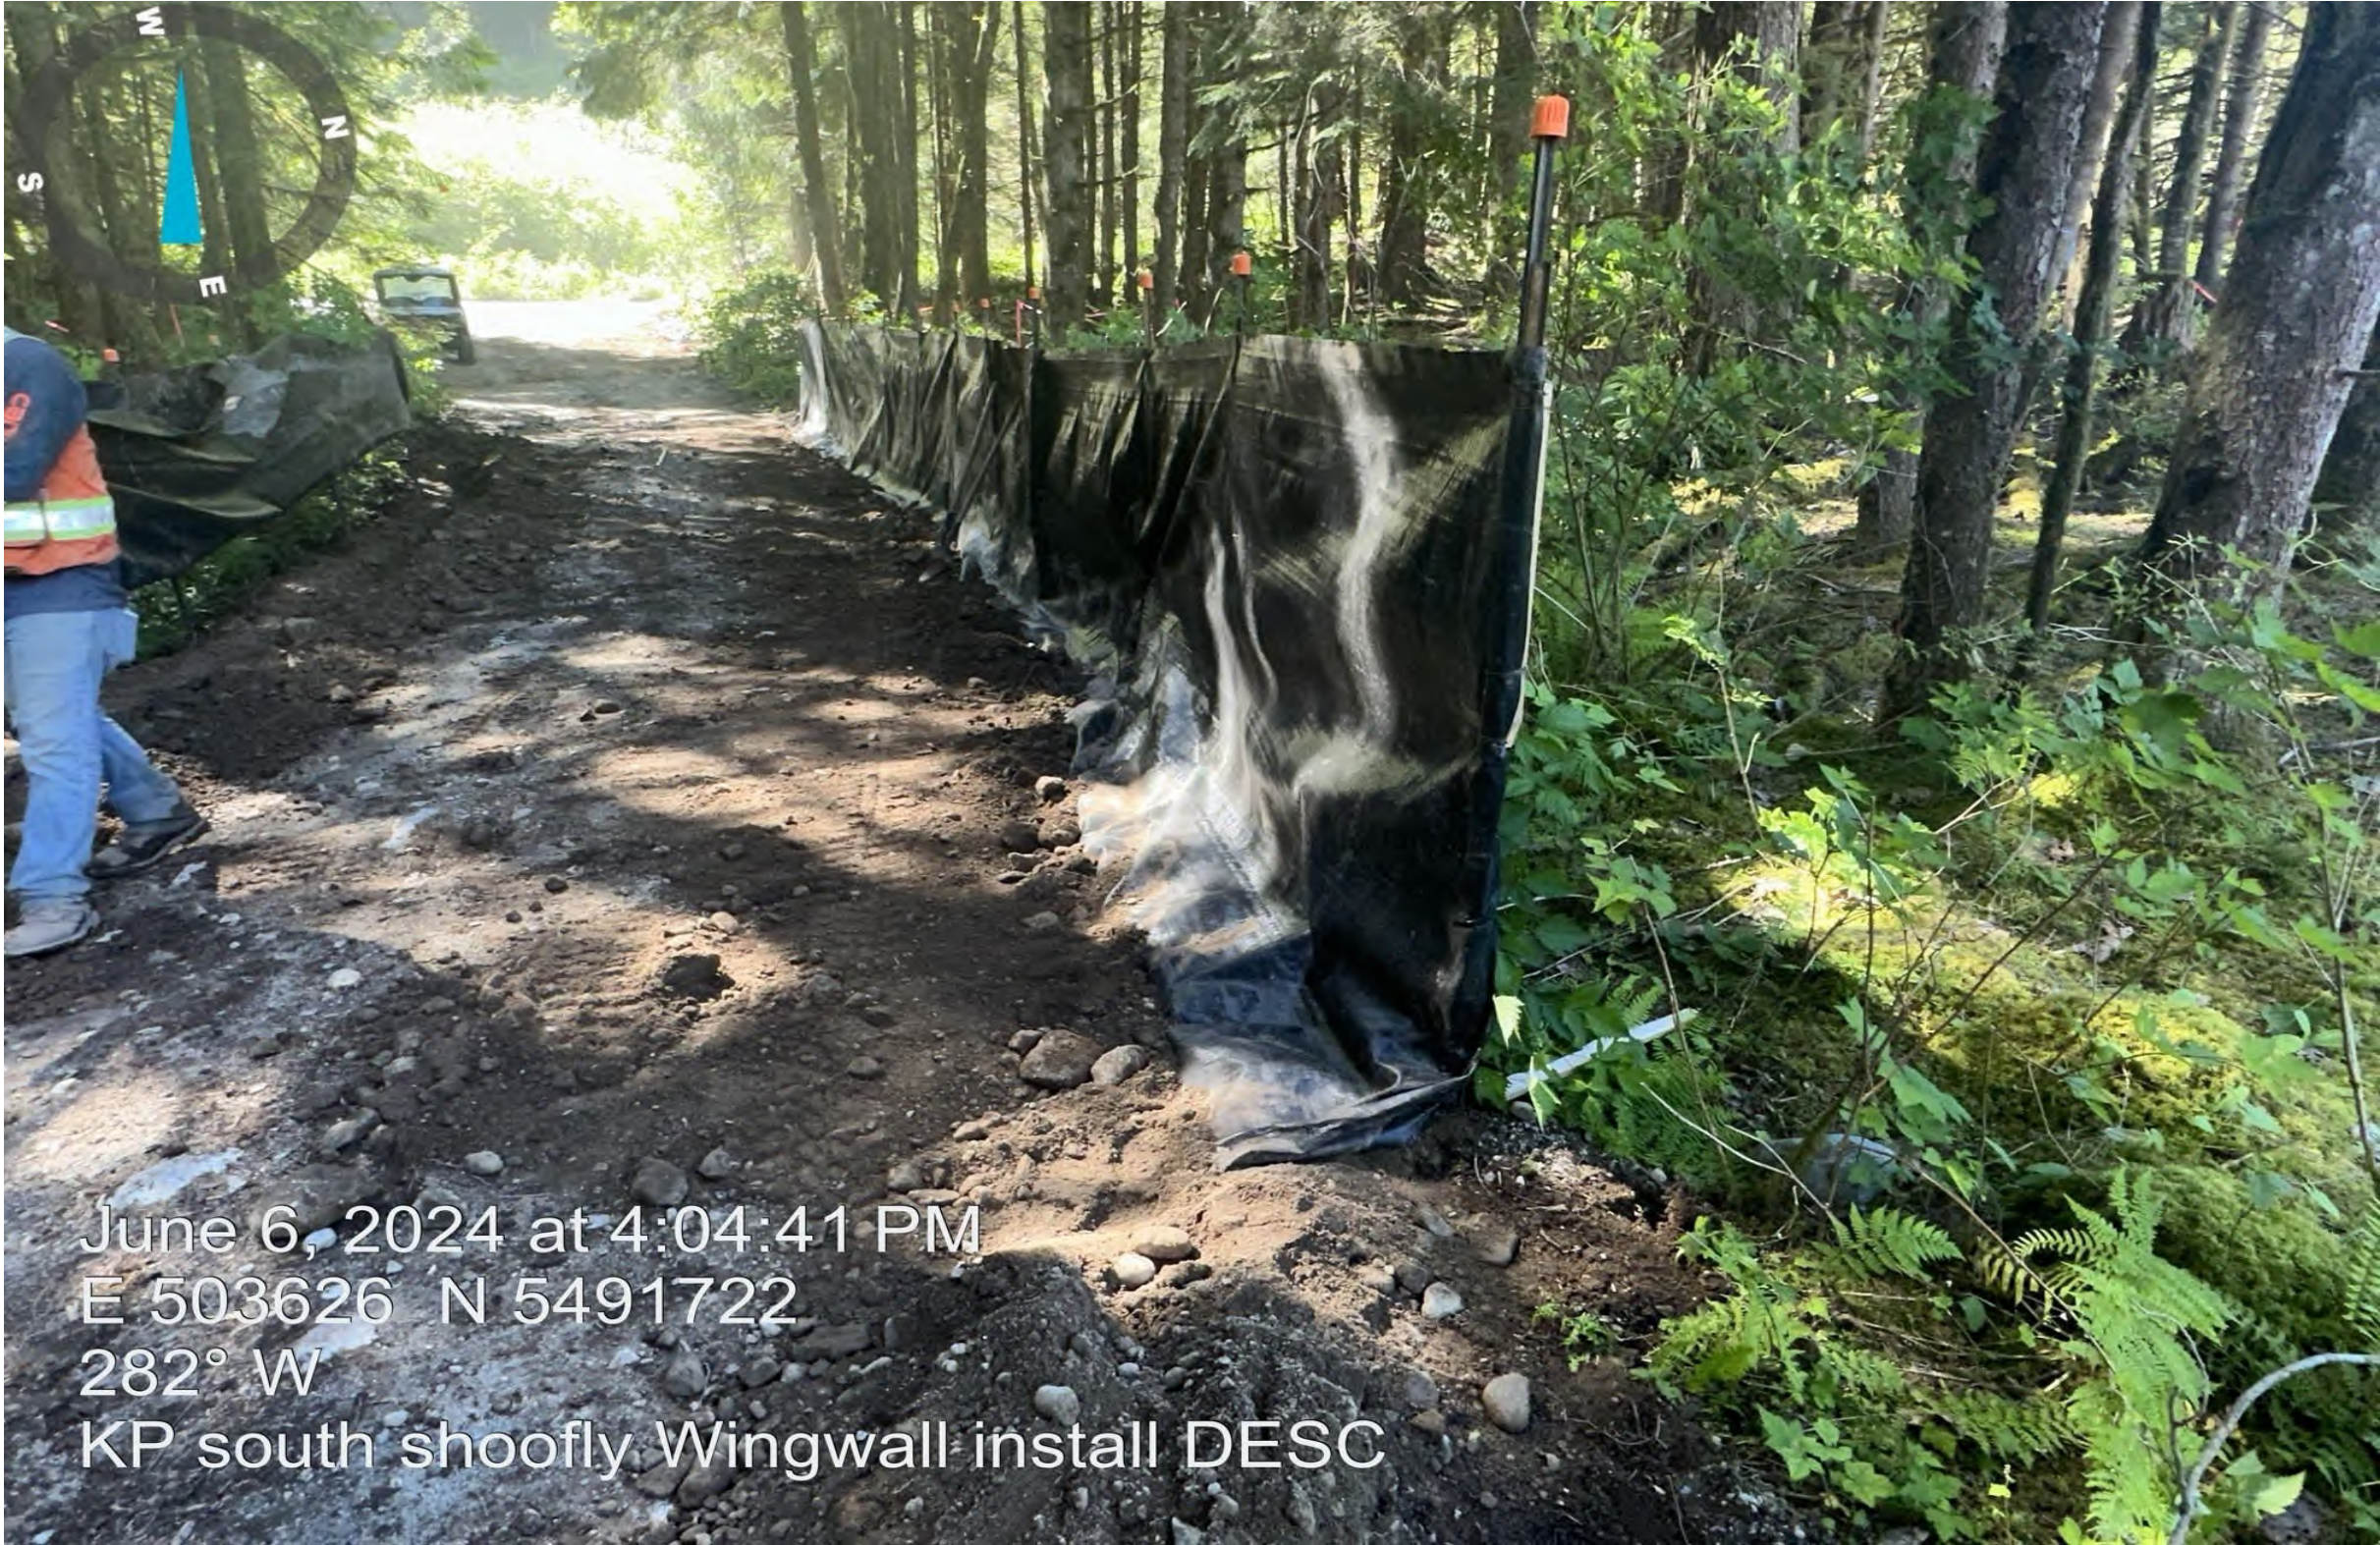
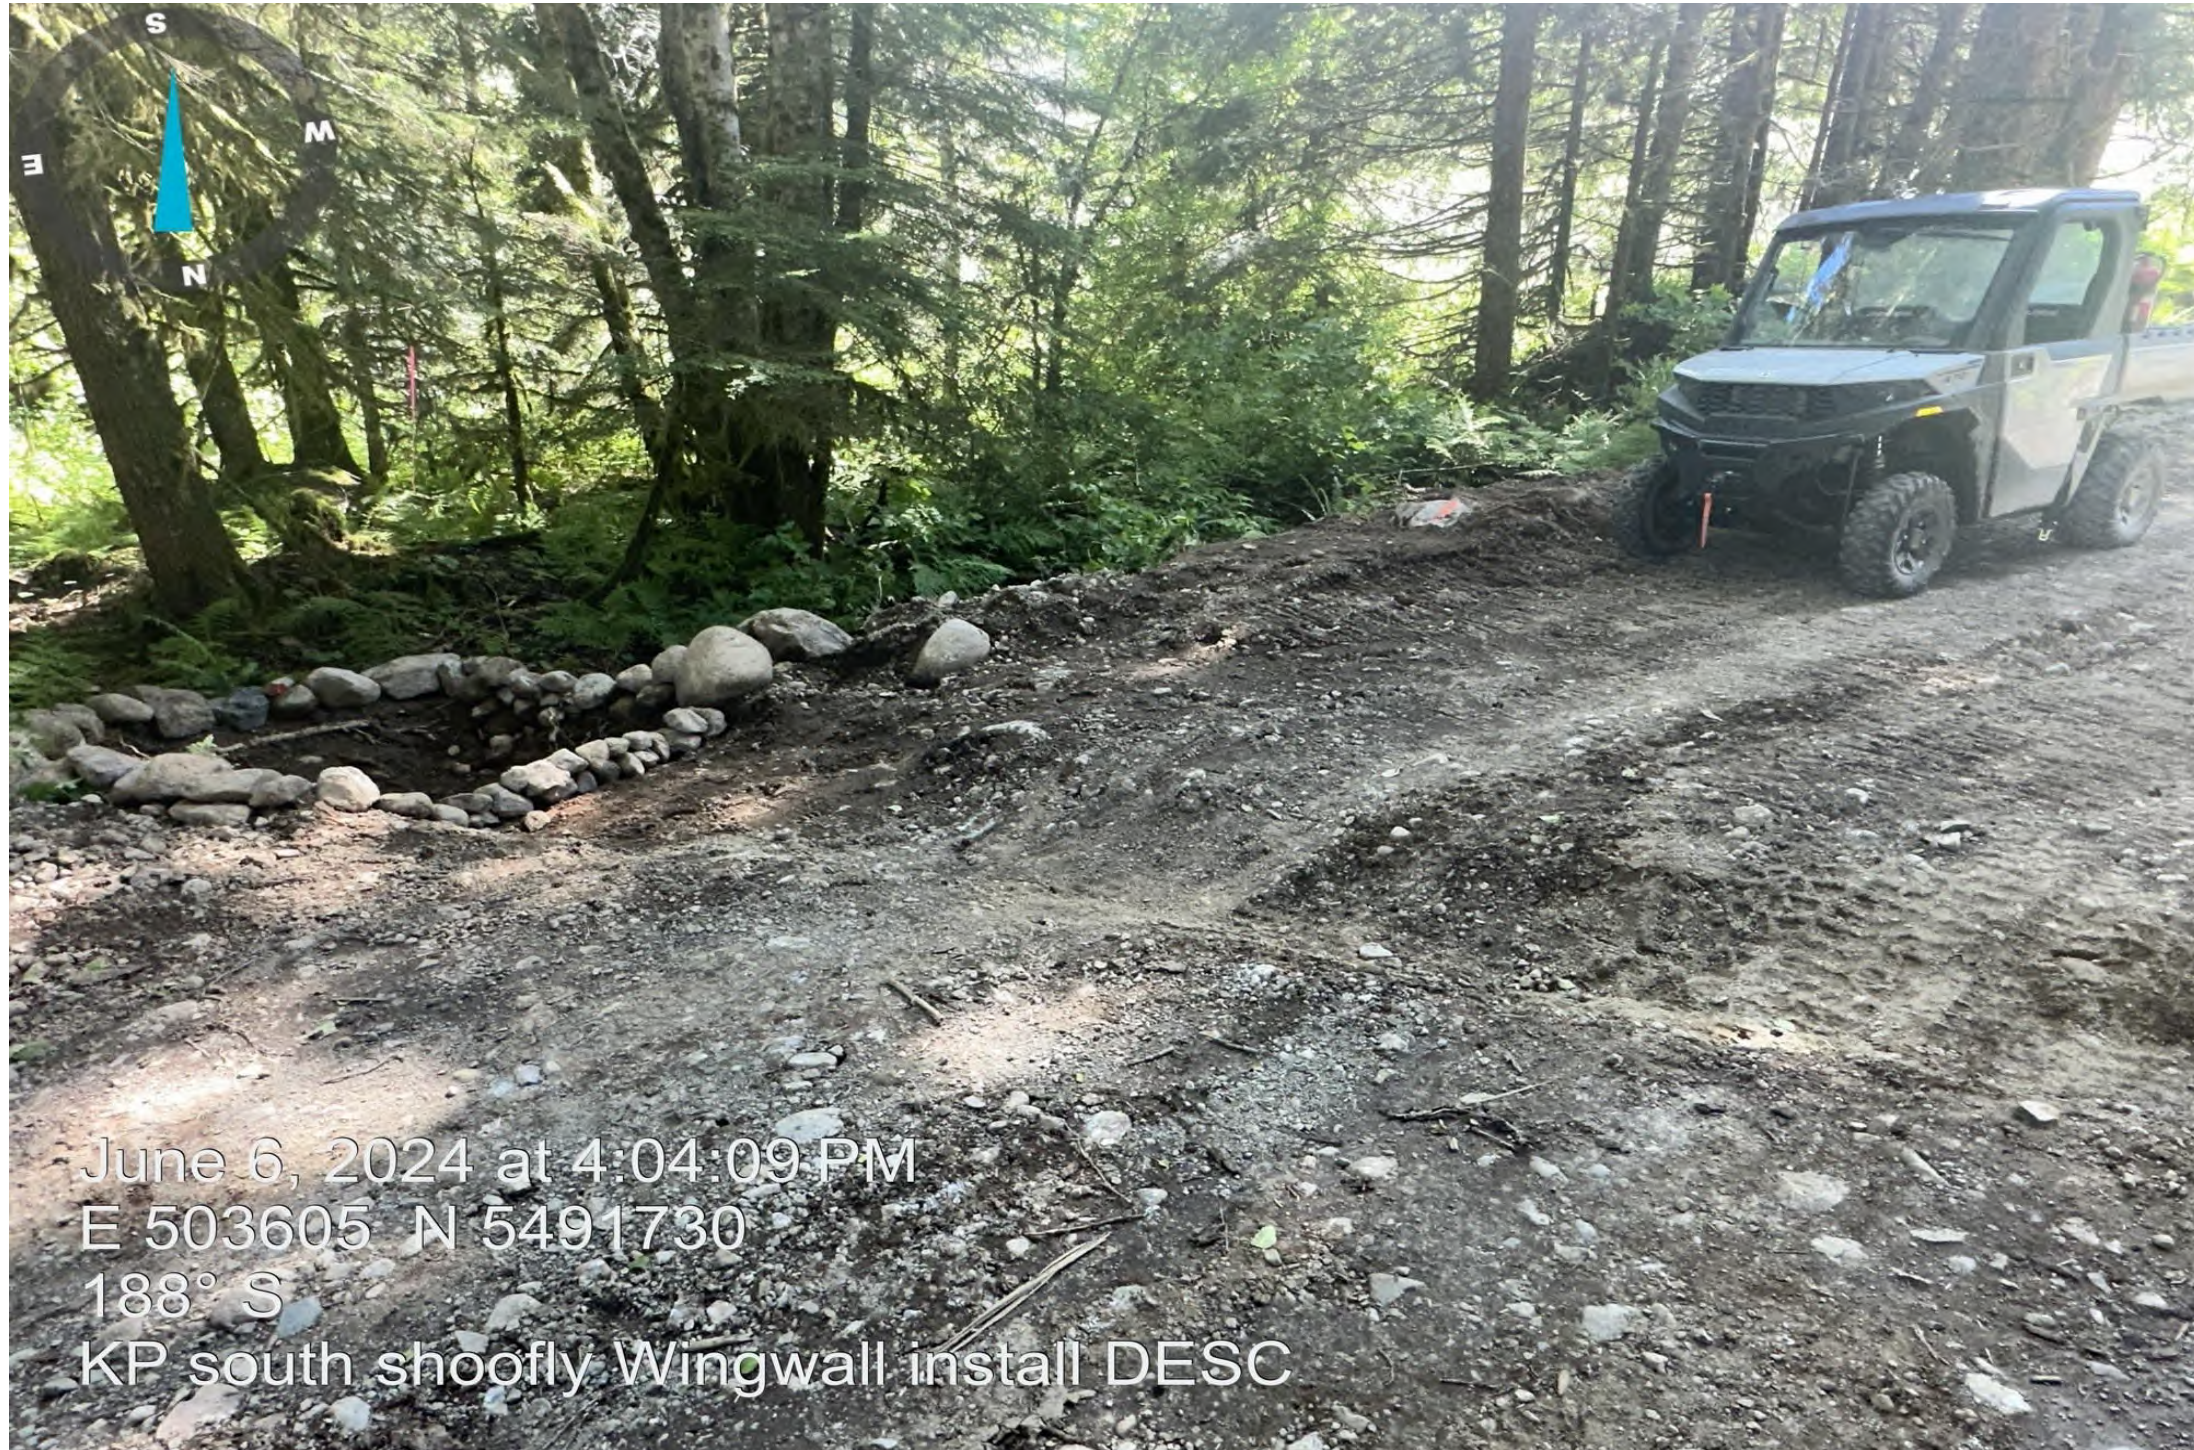
KP 14 lower laydown shoofly access wing wall keyed in and DESC installed (water bars with catchment

June 6, 2024 at 4:04:41 PM  
E 503626 N 5491722  
282° W  
KP south shoofly Wingwall install DESC

June 6, 2024 at 4:04:09 PM  
E 503605 N 5491730  
188° S  
KP south shoofly Wingwall install DESC

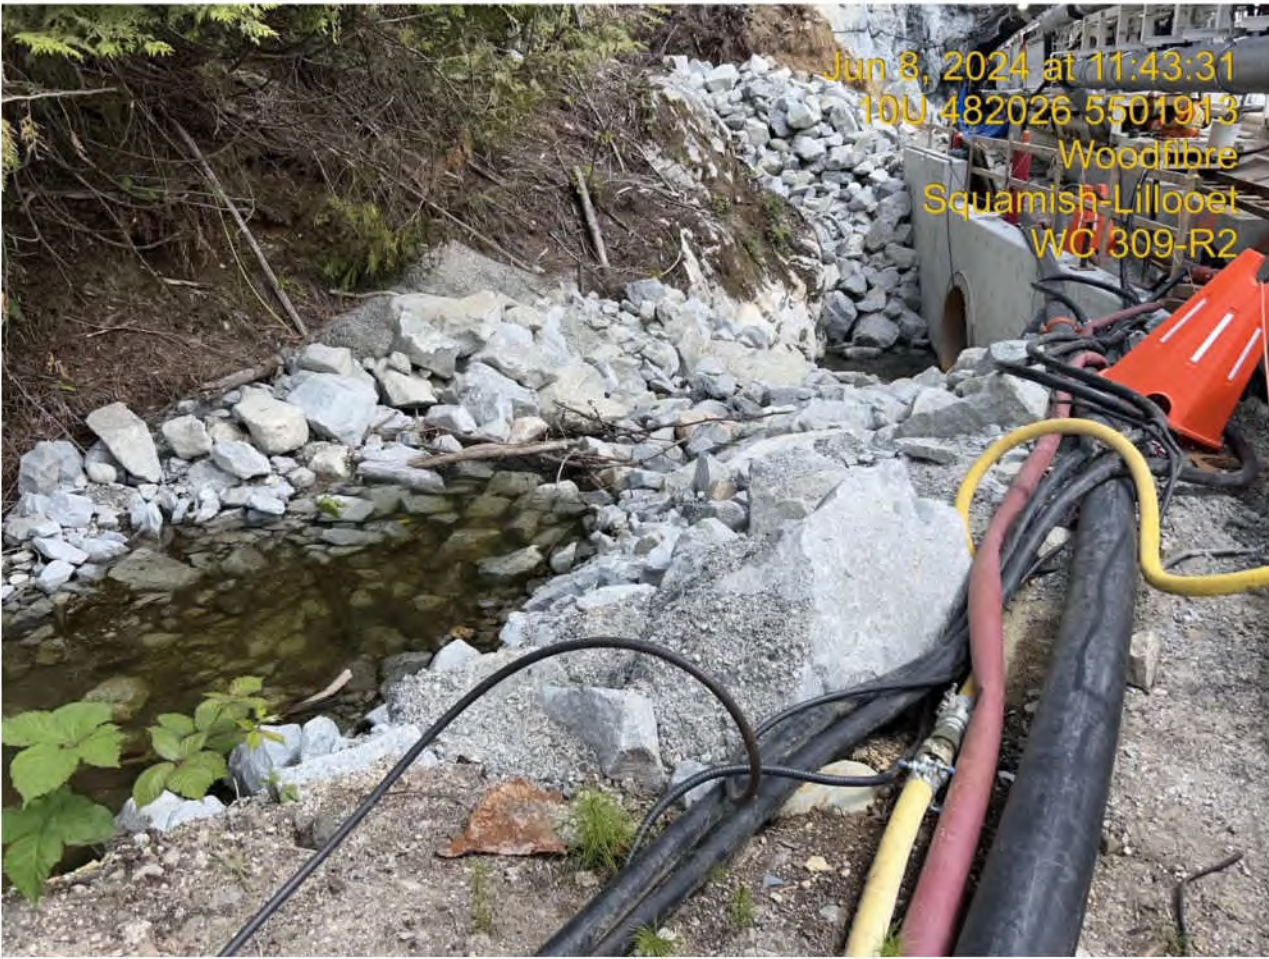
West Portal: yellow hose removed from WC 309-R2.

Jun 8, 2024 at 11:43:31  
10U 482026 5501913  
Woodfibre  
Squamish-Lillooet  
WC 309-R2

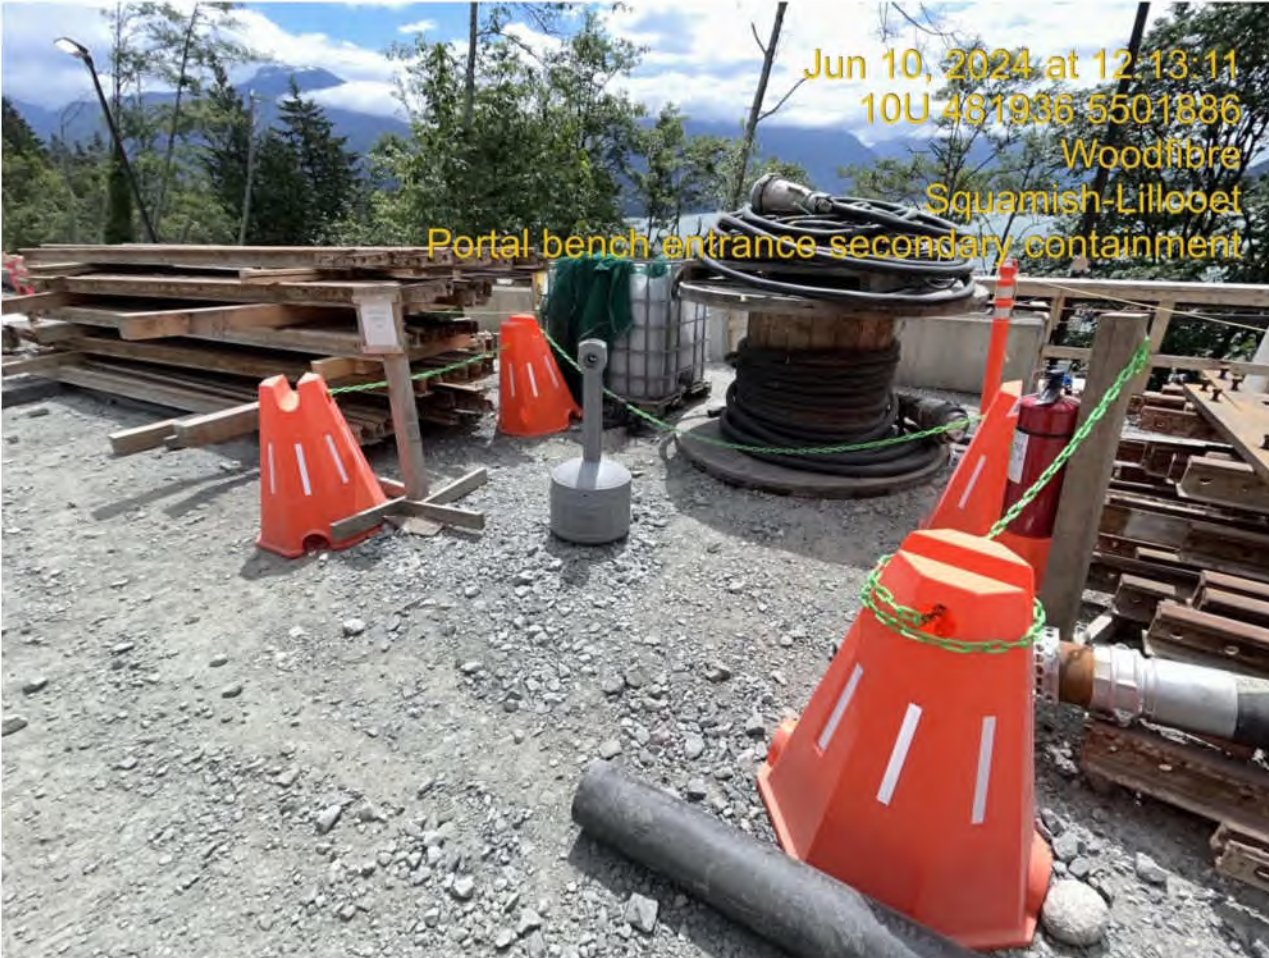
West Portal: designated smoking area moved to new location away from the secondary containment area.

Jun 10, 2024 at 12:13:11  
10U 481936 5501886  
Woodfibre  
Squamish-Lillooet  
Portal bench entrance secondary containment

Secondary containment at West Portal will be replaced later this week with a more permanent solution. Our contractor has order the Enviro-Liner 3000 (spec sheet attached). It is expected on site later this week.

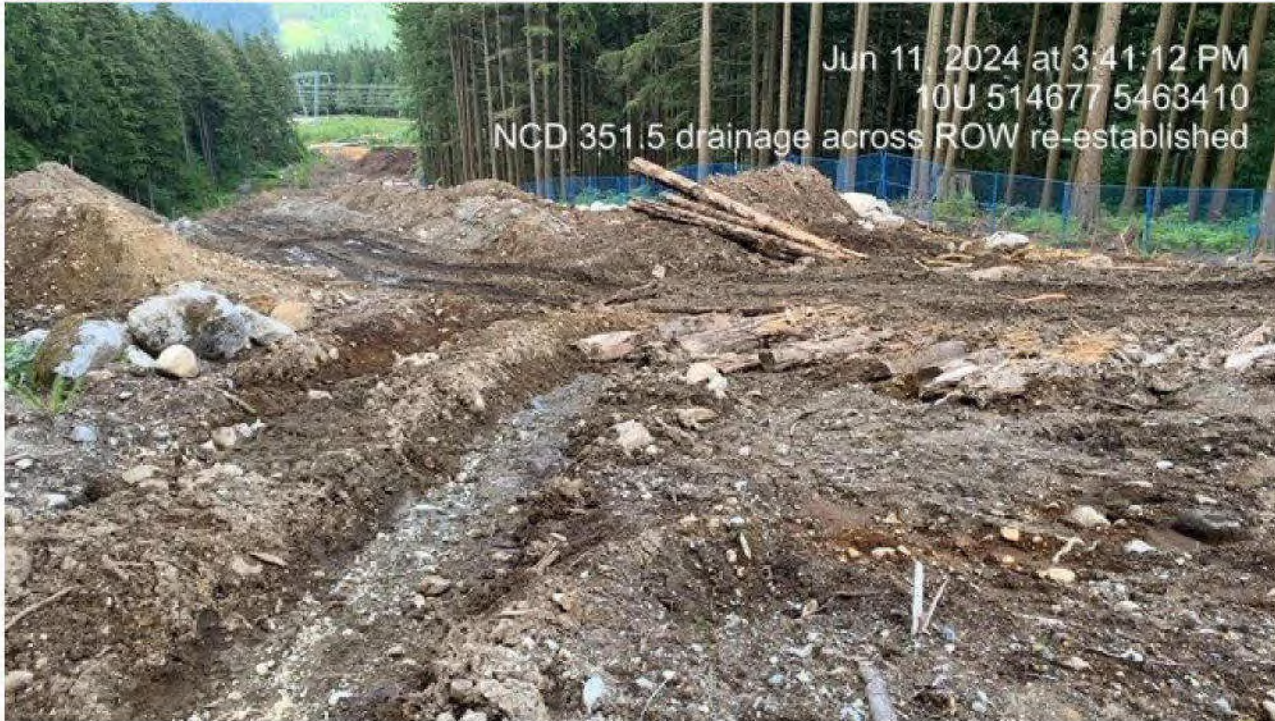
EGP South: KP 1+500 slope. Drainage re-established across the ROW. Further improvements will be made once grade works start in this location.

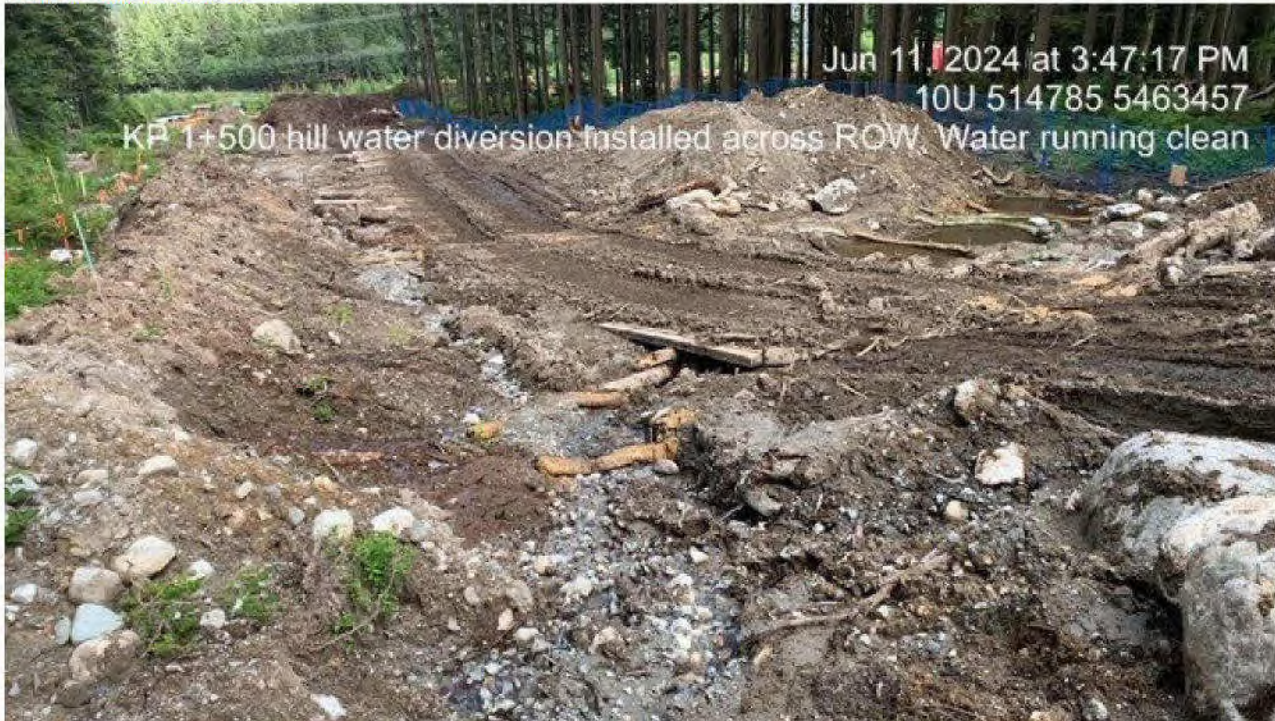
EGP South: KP 1+500 slope. Drainage re-established across the ROW. Further improvements will be made once grade works start in this location.

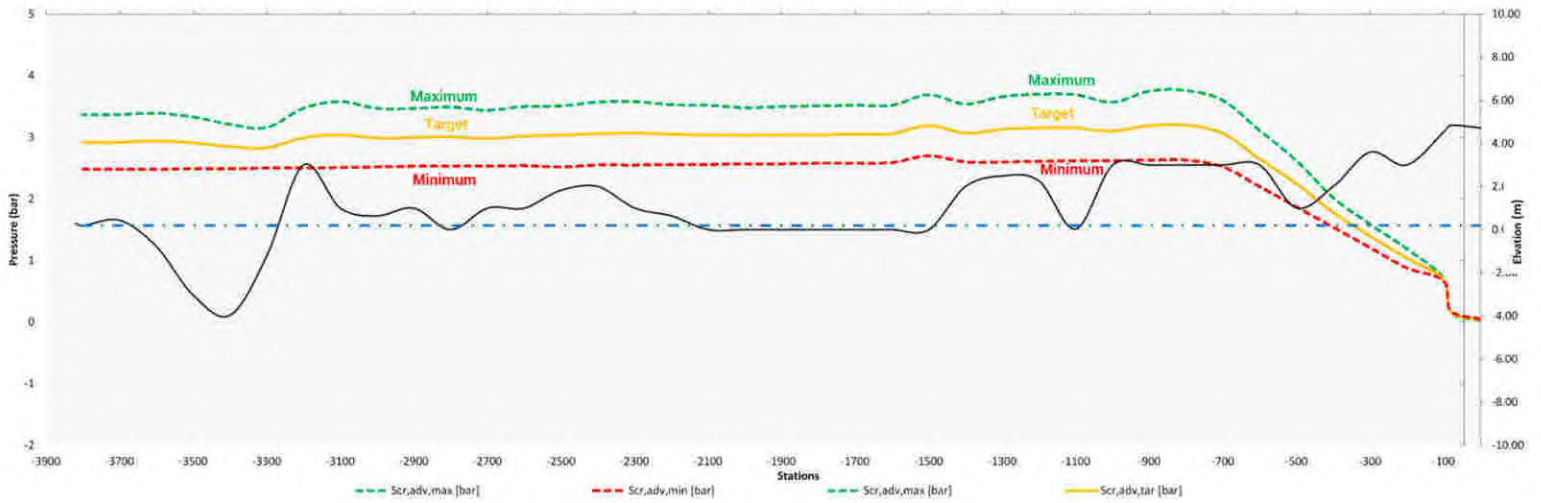
Recommended TBM Face Pressure @ Tunnel Crown

**Project:** Eagle Mountain - Woodfibre Gas Pipeline Project  
**Proj. Number:** APDU 2.4  
**Subject:** Face Pressures calculated based on DAUB (2016)  
**Dates:** 8/25/2022  
**Prepared by:** F. Mercuriello

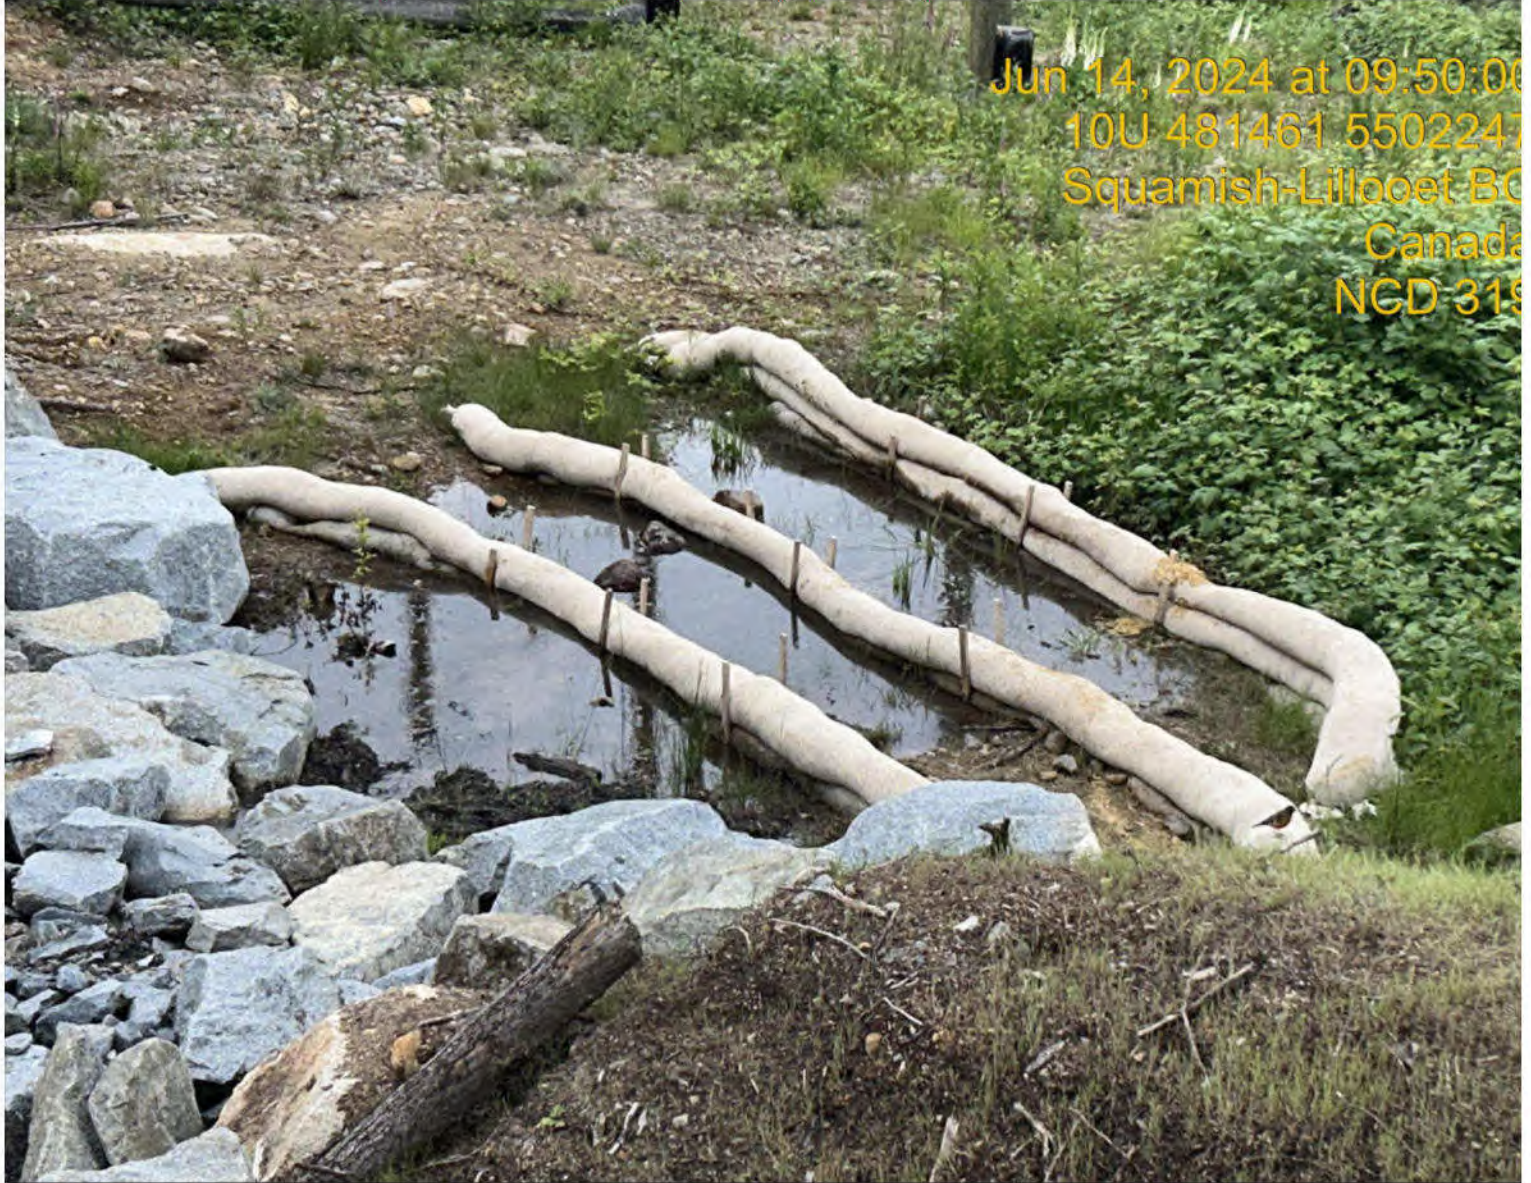
Photo 1: ESC maintenance completed at the lower quarry drainage (NCD 319) at the WLNG site.

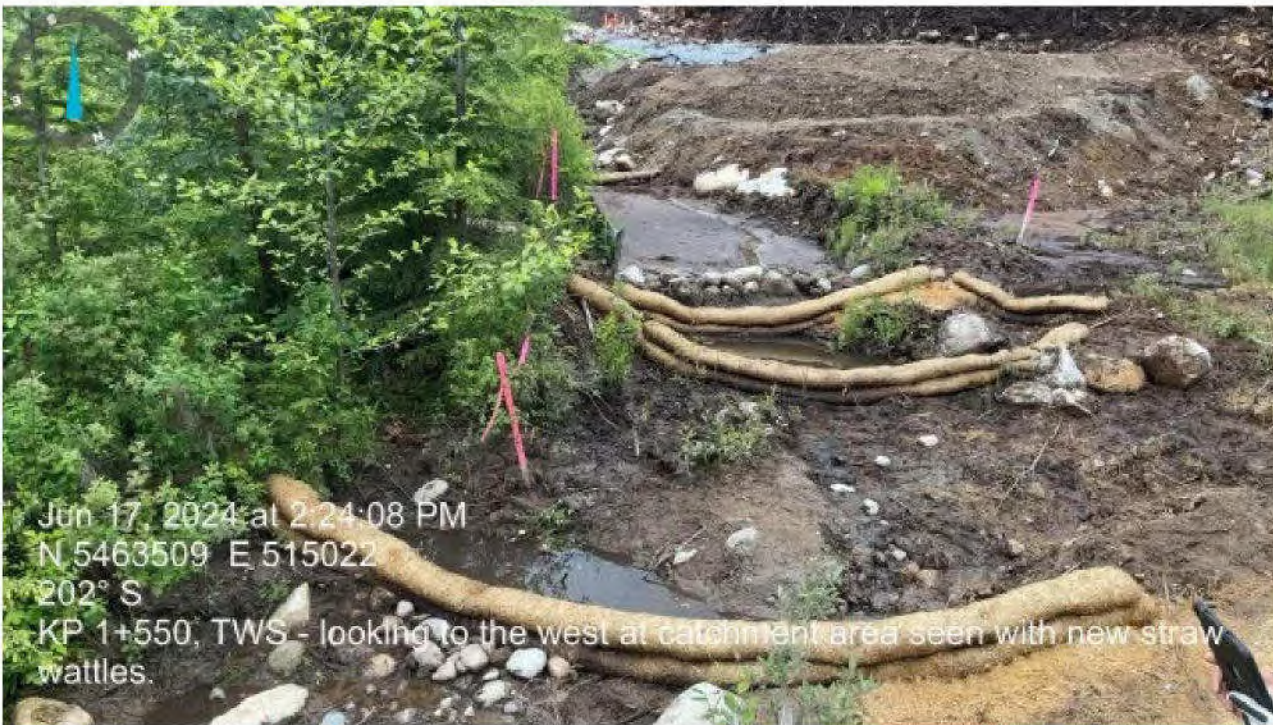
Photo 2: ESC maintenance has been completed (and is ongoing) in the perimeter ditch adjacent to shoofly 6 at EGP South. With the improved water management upslope on the KP 1+500 slope, this area has less water directed to it.

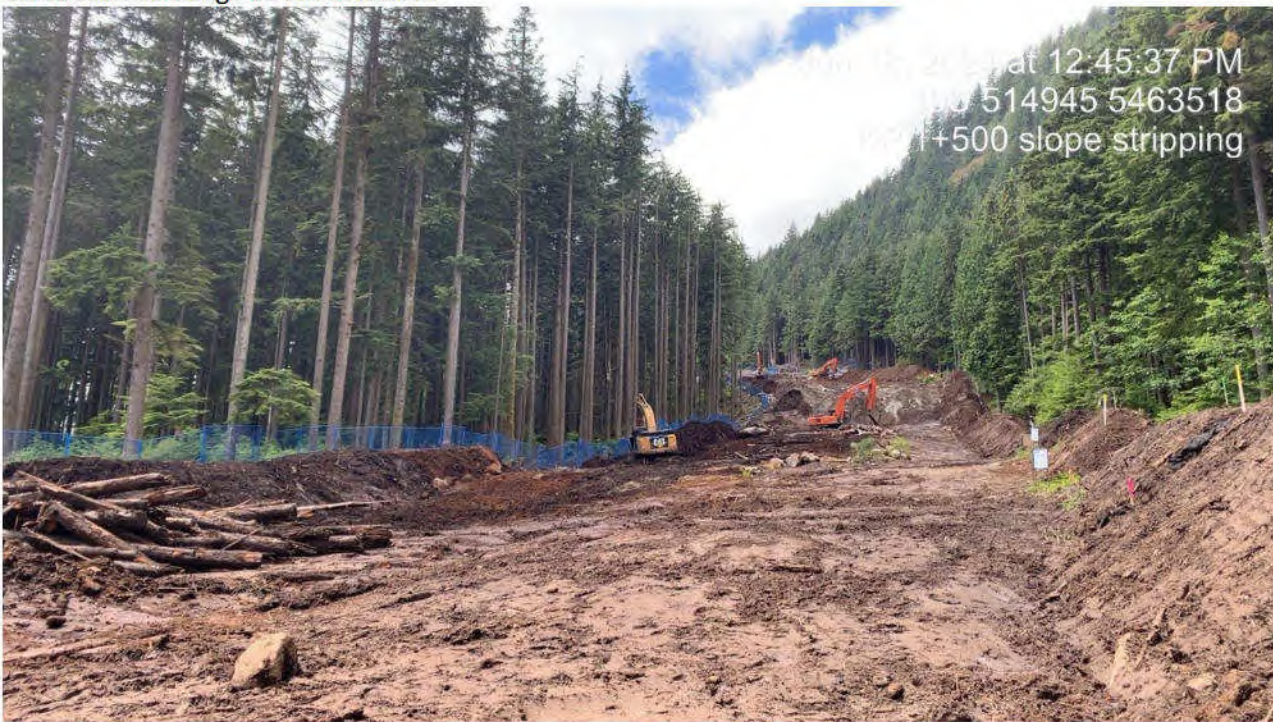
Photo 3: Stripping at the KP 1+500 slope. Water management with the installation of cross drains on the ROW has improved overall site drainage at this location.

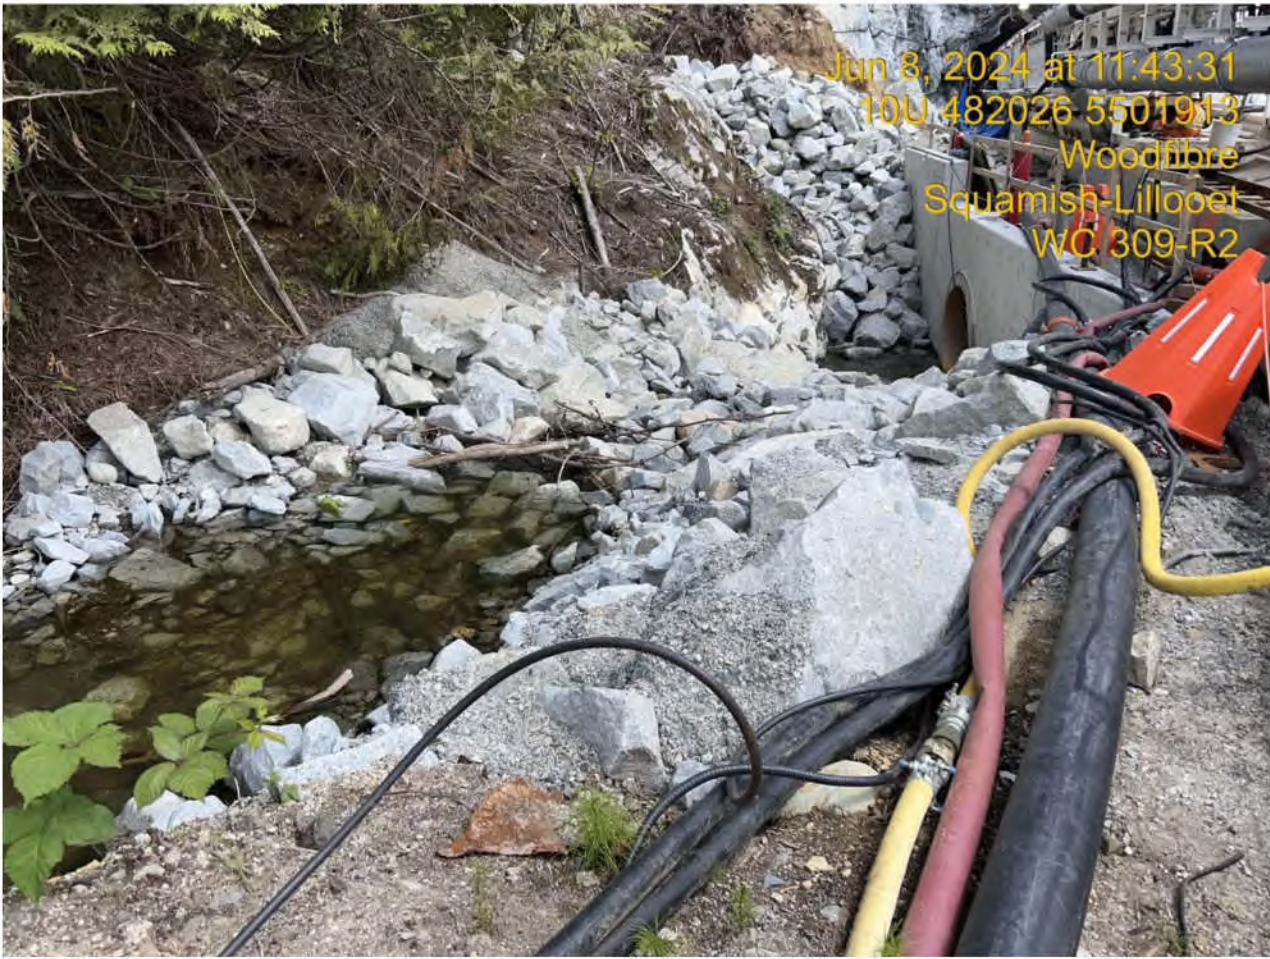
West Portal: yellow hose removed from WC 309-R2.

Jun 8, 2024 at 11:43:31  
10U 482026 5501913  
Woodfibre  
Squamish-Lillooet  
WC 309-R2

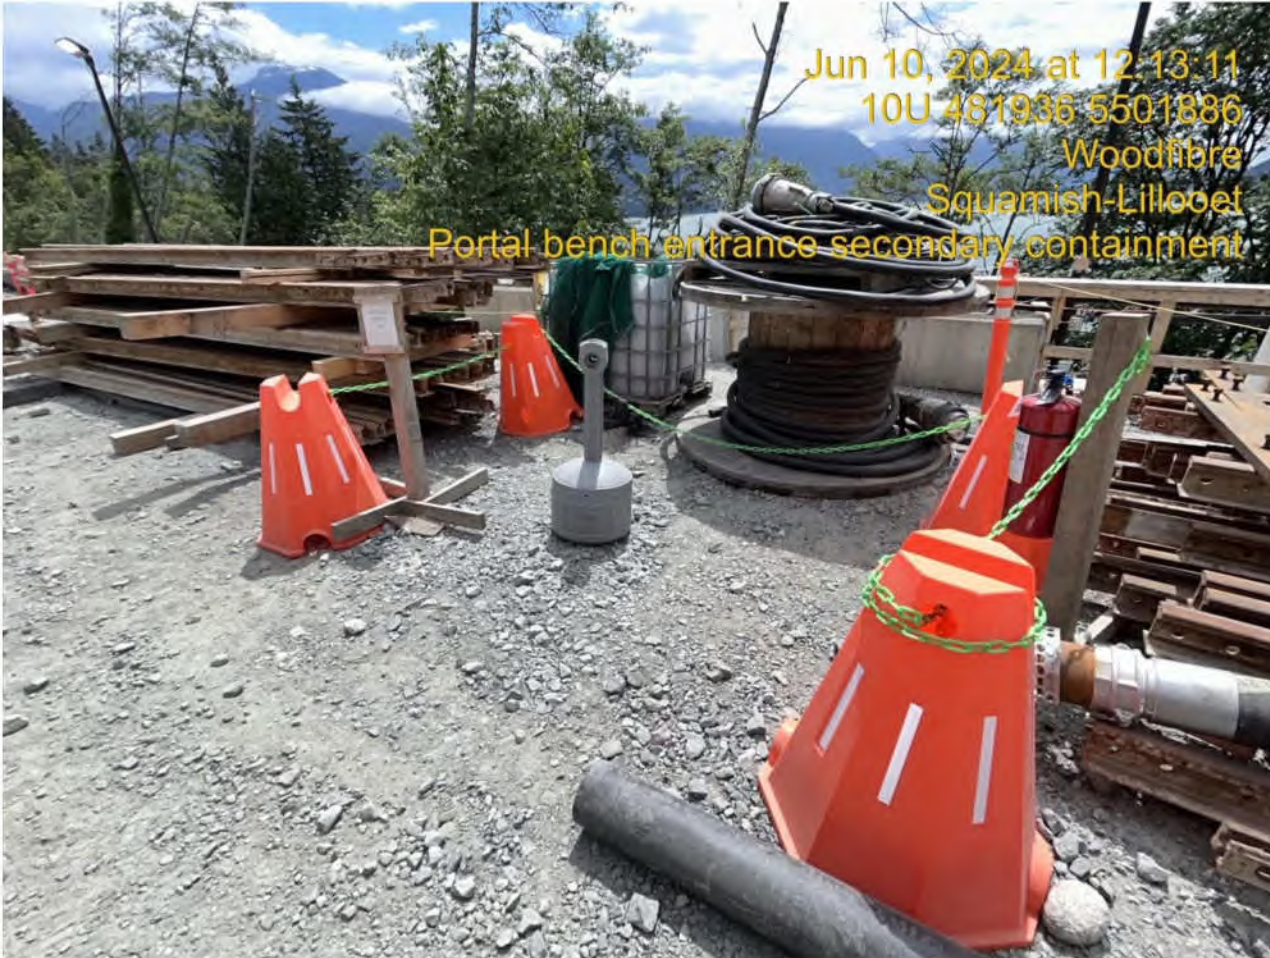
West Portal: designated smoking area moved to new location away from the secondary containment area.

Jun 10, 2024 at 12:13:11  
10U 481936 5501886  
Woodfibre  
Squamish-Lillooet  
Portal bench entrance secondary containment

Secondary containment at West Portal will be replaced later this week with a more permanent solution. Our contractor has order the Enviro-Liner 3000 (spec sheet attached). It is expected on site later this week.

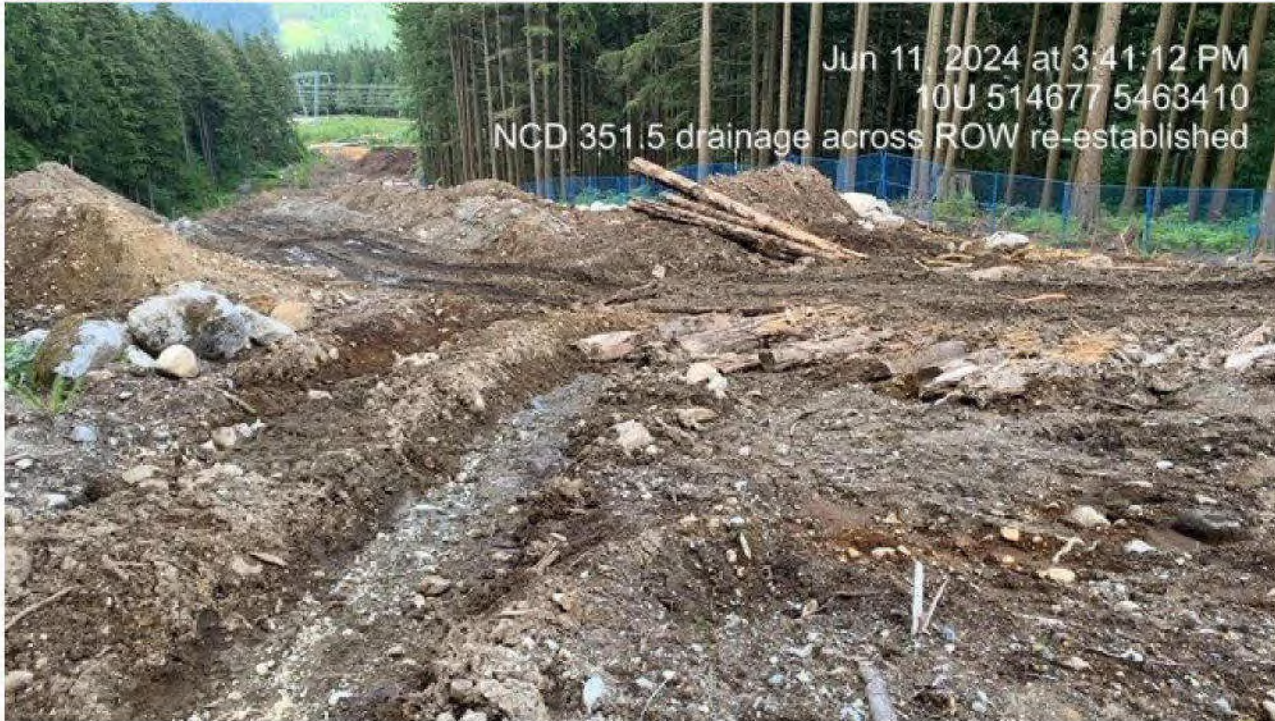
EGP South: KP 1+500 slope. Drainage re-established across the ROW. Further improvements will be made once grade works start in this location.

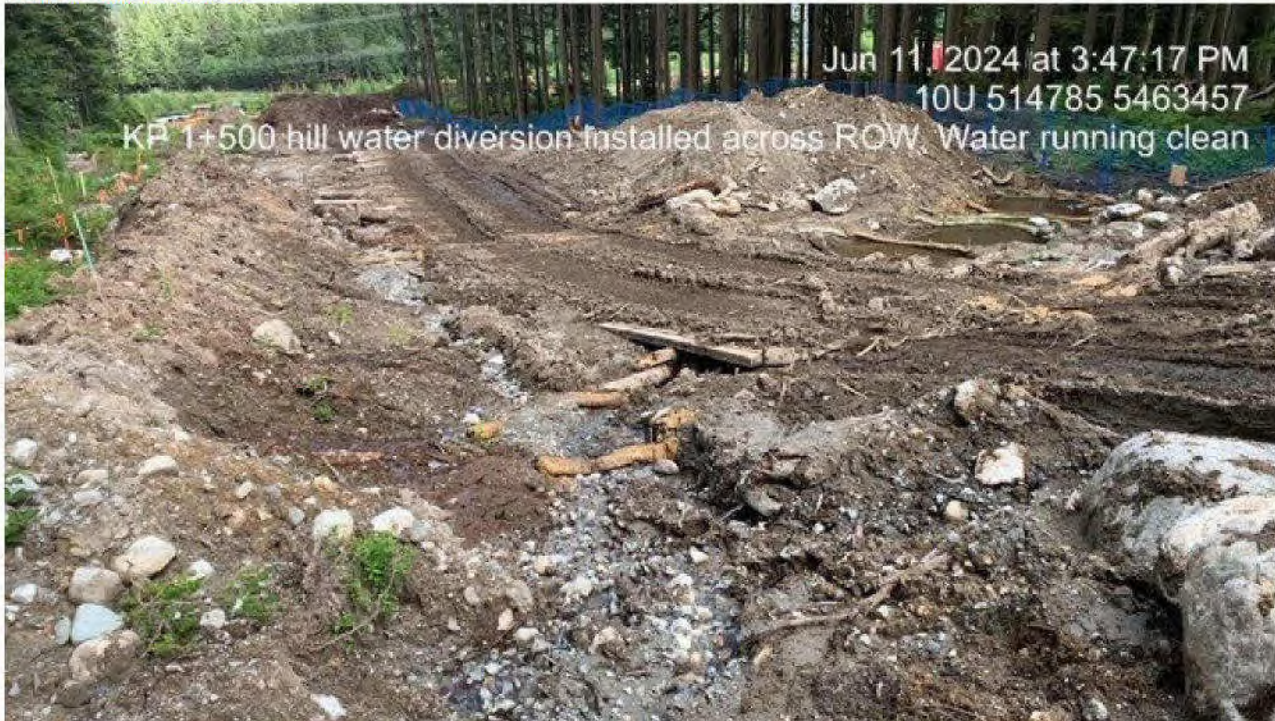
EGP South: KP 1+500 slope. Drainage re-established across the ROW. Further improvements will be made once grade works start in this location.

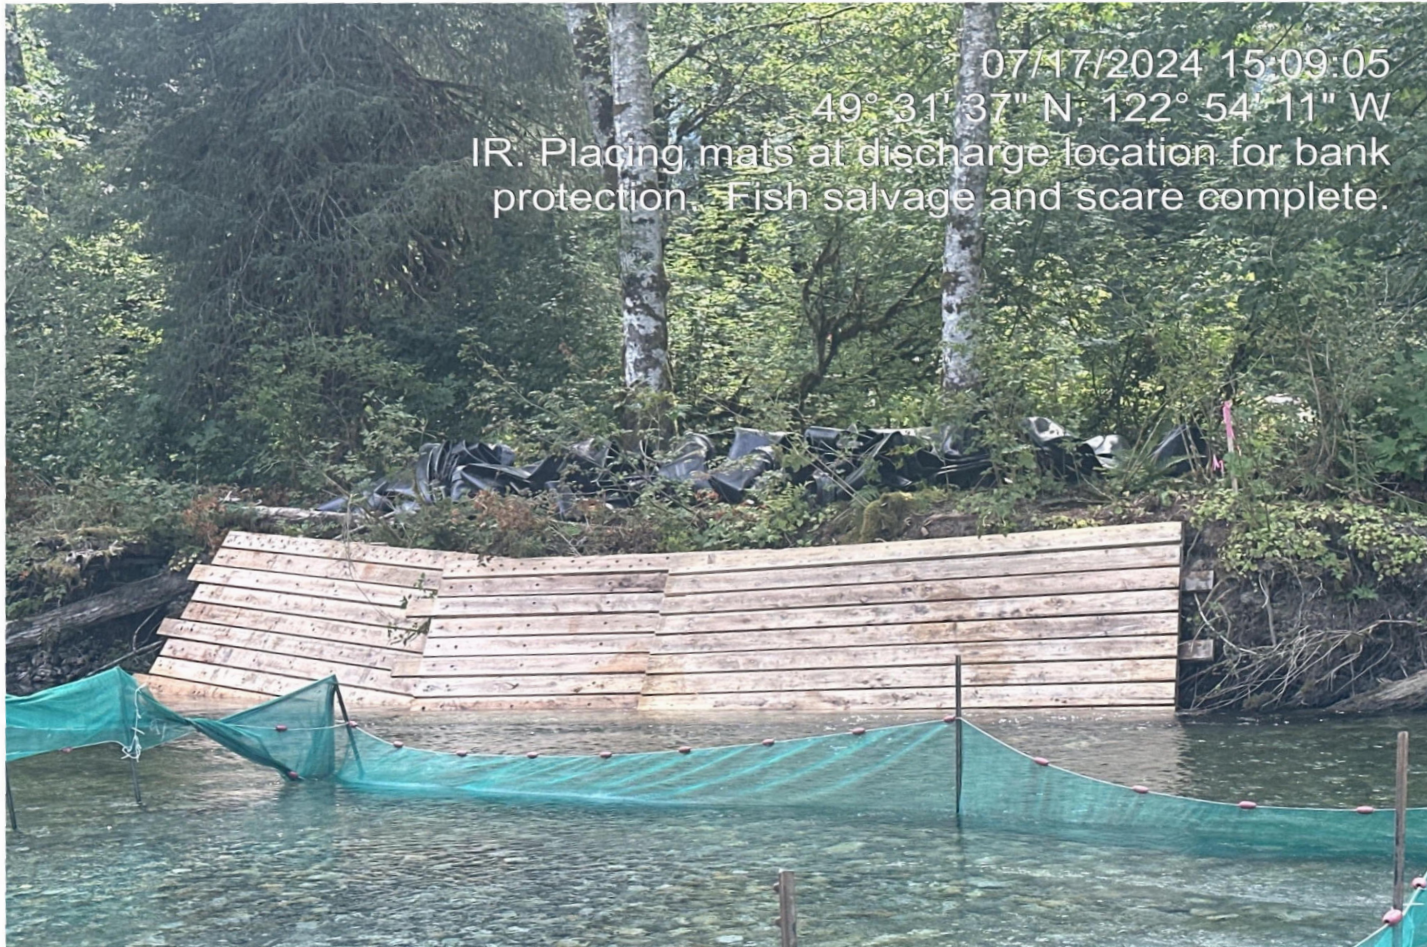
IR. Placing mats at discharge location for bank protection. Fish salvage and scare complete.

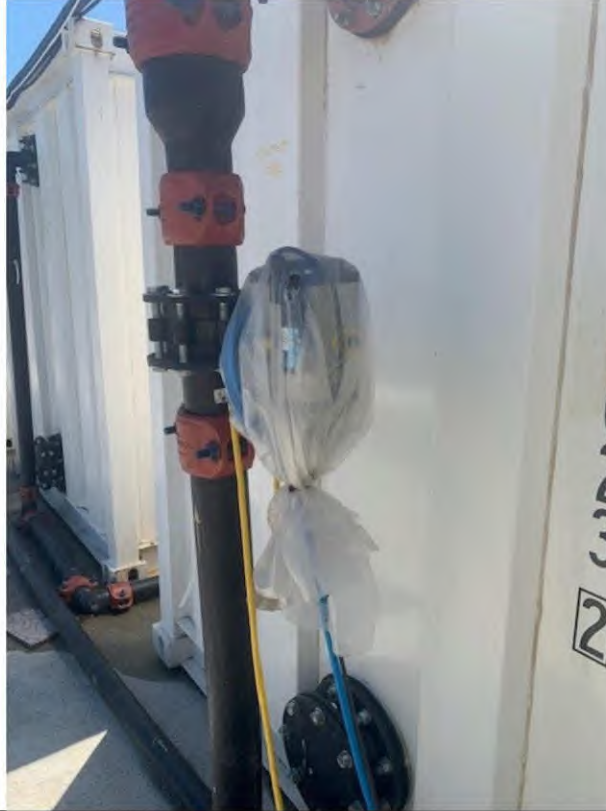
Automatic Shut Off Valve: Manual Override / Not Functioning

The shut off valve at the pre-treatment valve has been switched from manual override to automatic and a lock placed on the shut-off which will prevent the tanks from overflowing when the pump is left on. A pressure switch will be activated when the valve is automatically shut which is the primary control for the "Well pump system" which stops the pump once the WTP automatic volume level sensor shuts the WTP pretreatment valve.  
 A checklist/formal procedure is now being utilized as a pre and end of shift checklist ensuring no valves or pumps are left in the incorrect position.
