## Inspection Report

Permit Holder: FortisBC Energy Inc.  
Inspection: 2023-3137  
Inspection Date: 2023-10-24  
Inspection Outcome: In Compliance

#### Woodfibre Site

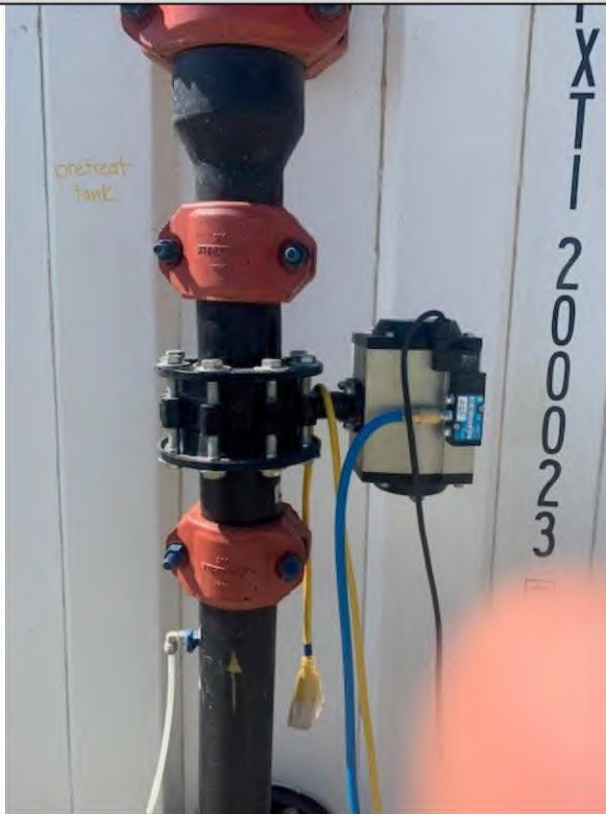
Automatic Shut Off Valve Set Up: Functioning with Automatic Shut-off

The shut off valve at the pre-treatment valve has been switched from manual override to automatic and a lock placed on the shut-off which will prevent the tanks from overflowing when the pump is left on. A pressure switch will be activated when the valve is automatically shut which is the primary control for the "Well pump system" which stops the pump once the WTP automatic volume level sensor shuts the WTP pretreatment valve.  
 A checklist/formal procedure is now being utilized as a pre and end of shift checklist ensuring no valves or pumps are left in the incorrect position.

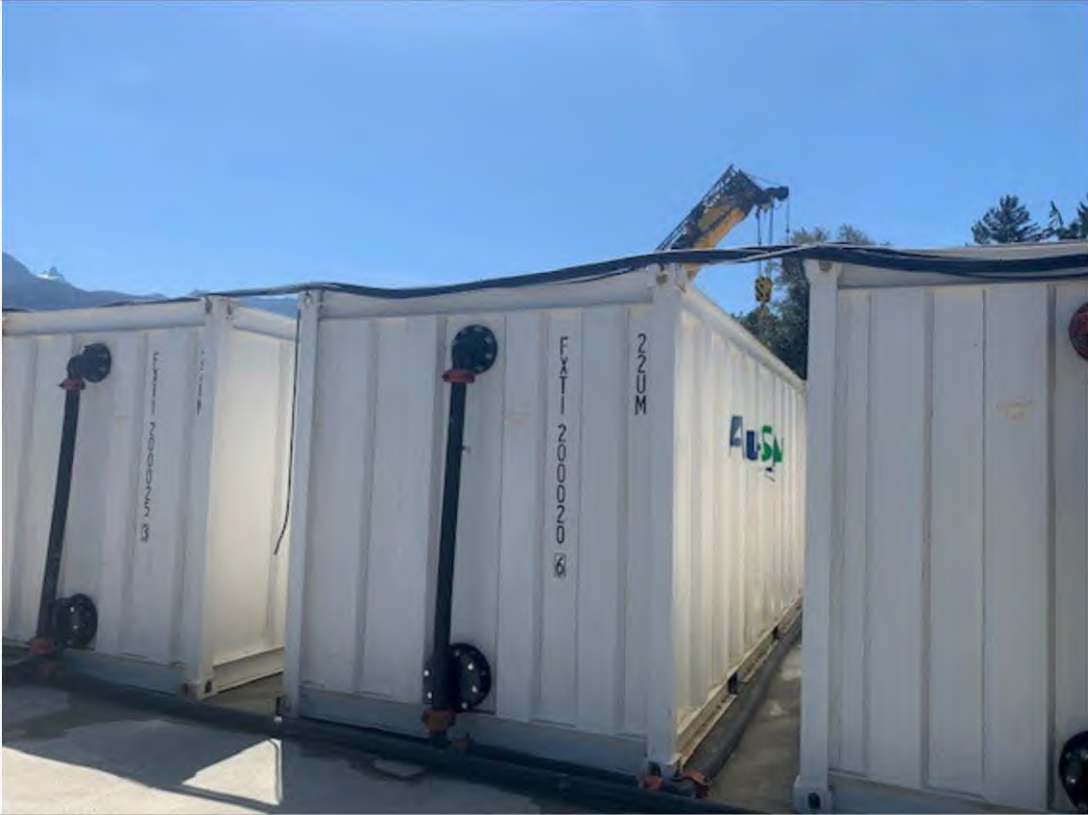
**Well Water Intake Storage Tanks Where Spill Occurred**
